Figure 1. North Branch Park River Study Area Overview
MDC Blue Hills/Granby Drainage Study
North Branch Park River Field Study
Hartford, CT

Attachment A

Site Photographs

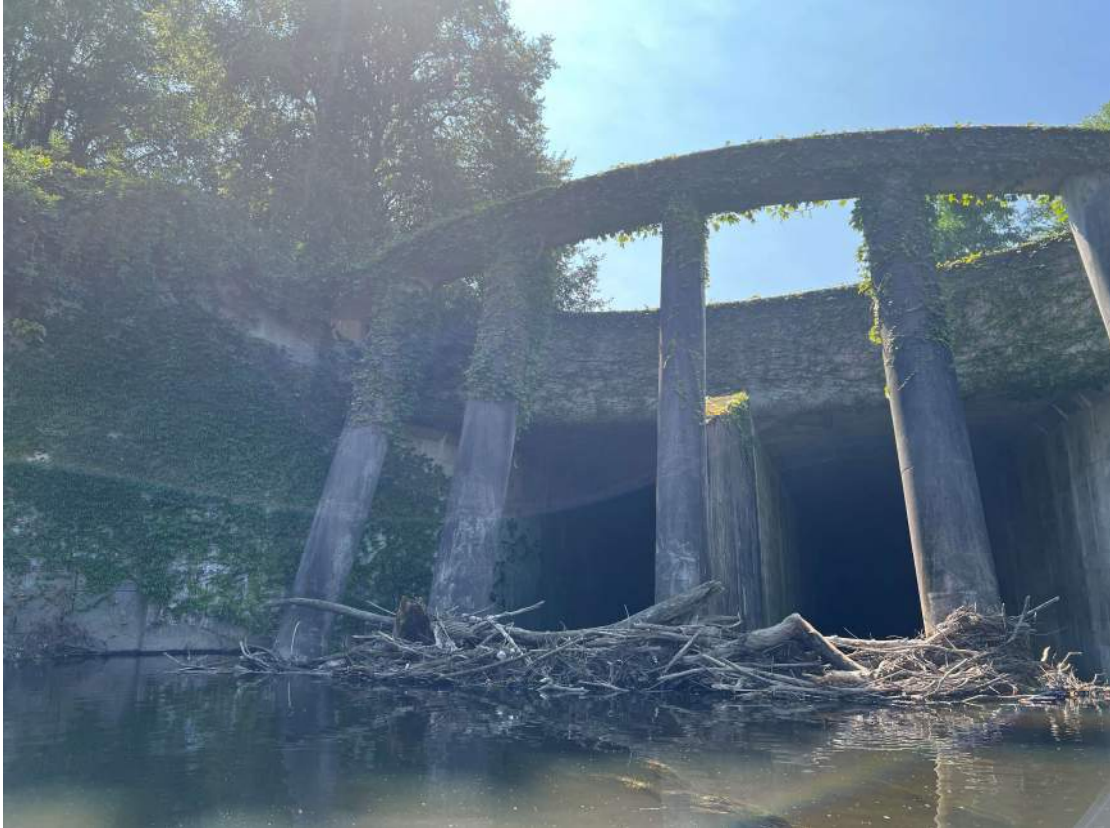
Photo 1: Debris dam at start of Segment 1, Park River Conduit (See Figure 3-1, TD-1).

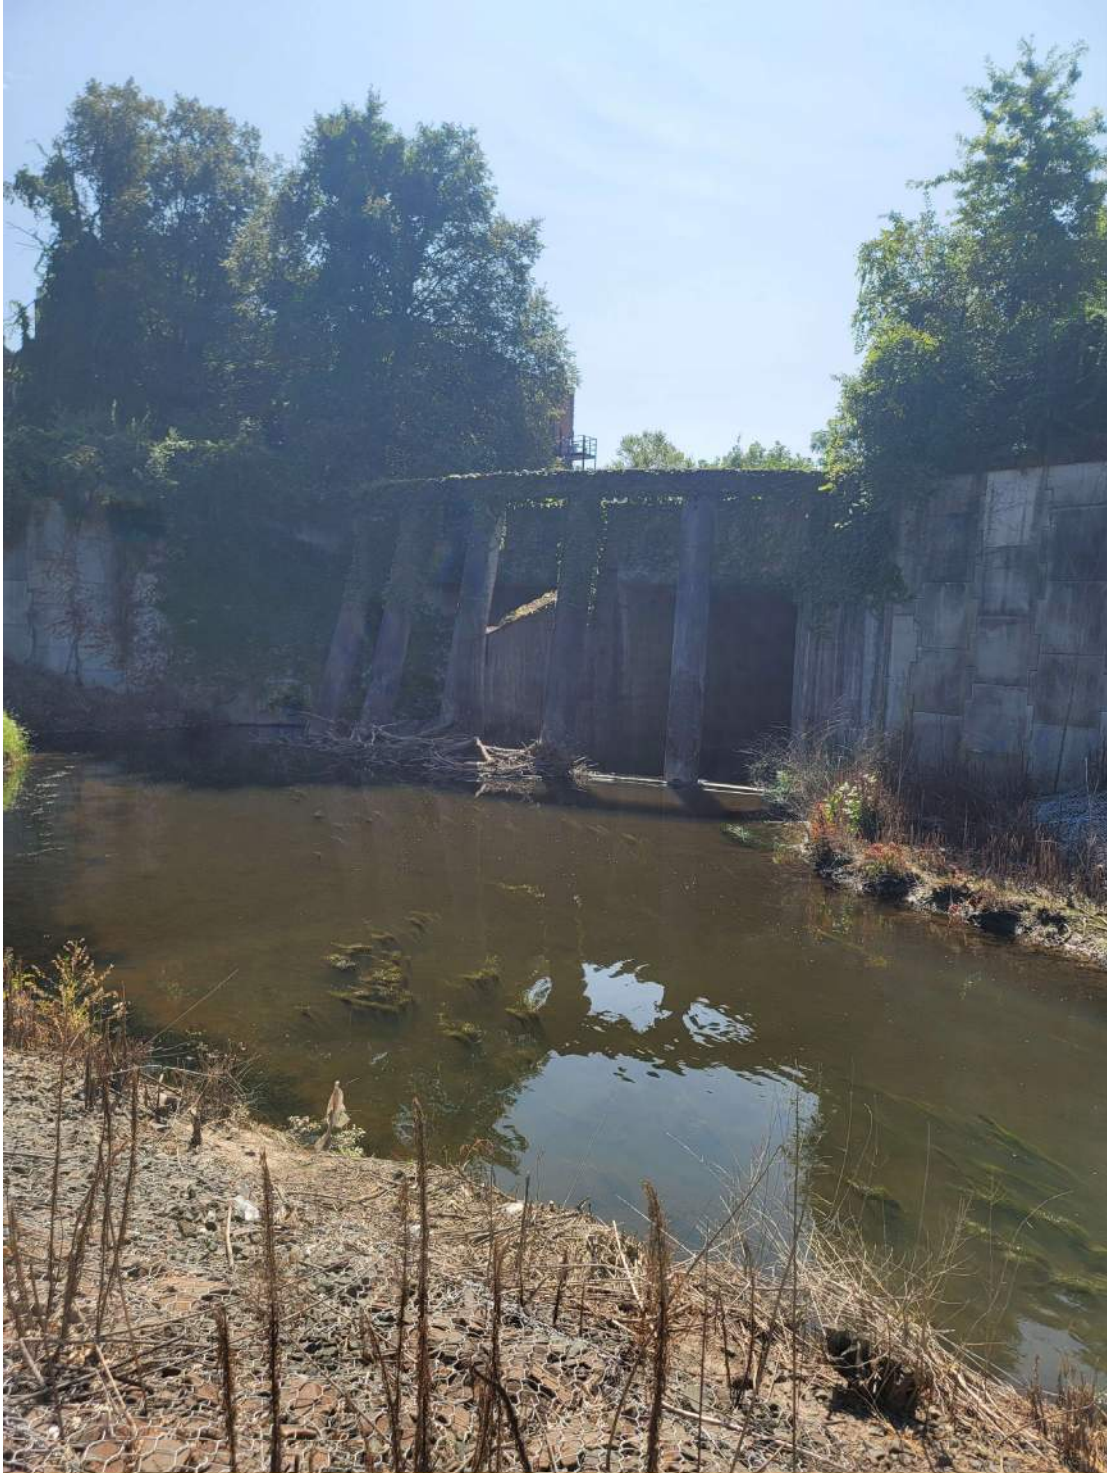
Photo 2: Water pooling directly upstream of Park River Conduit (Segment 1).

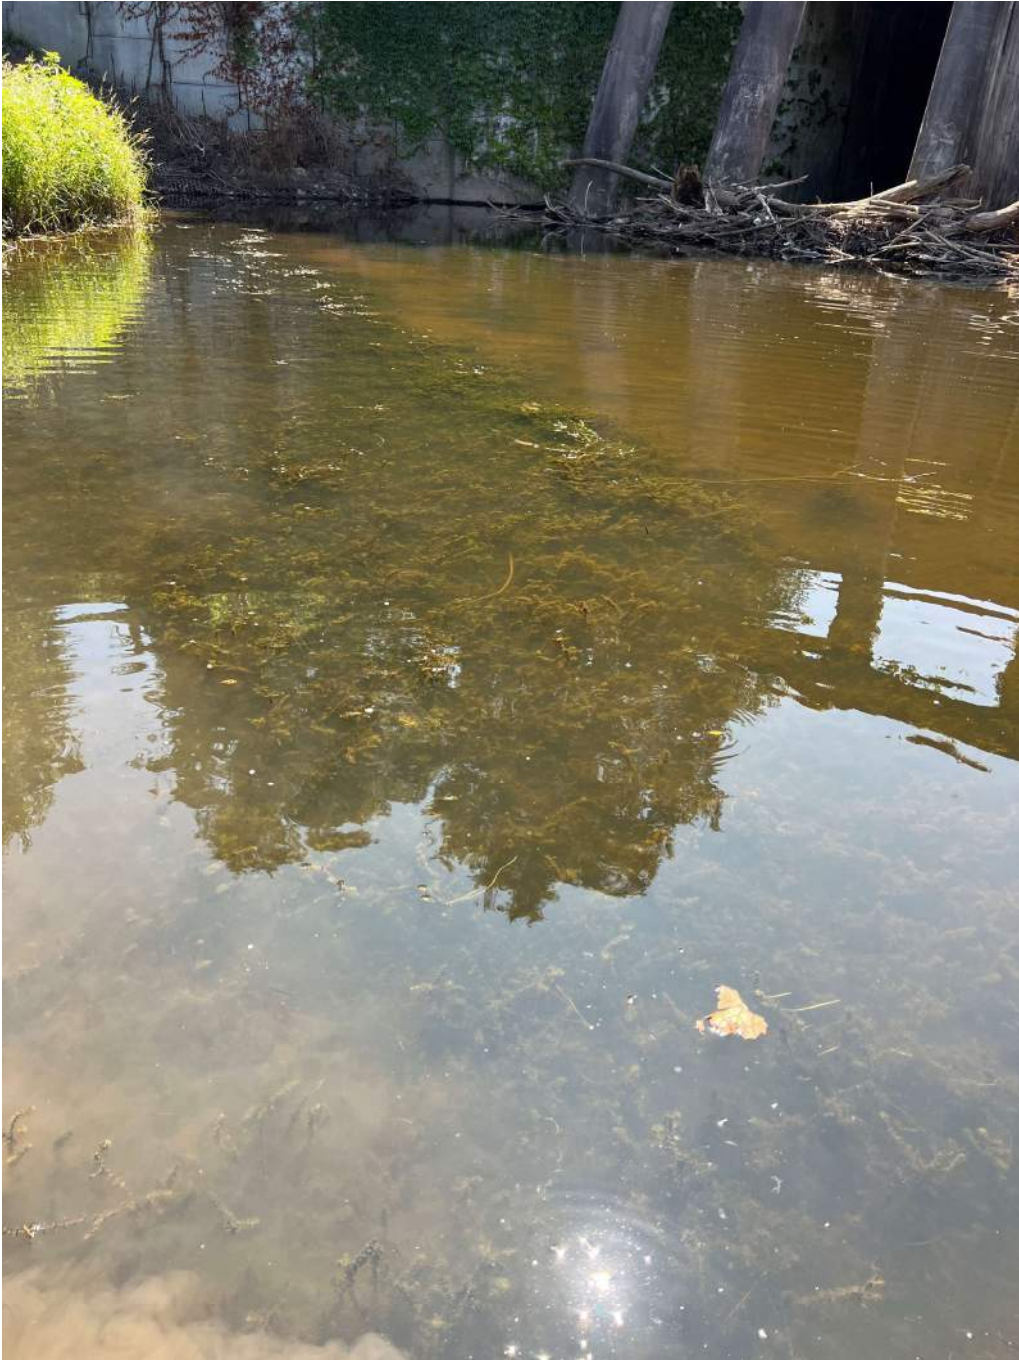
Photo 3: Vegetation island to the upper left of this photo, submerged aquatic vegetation visible (Segment 1).

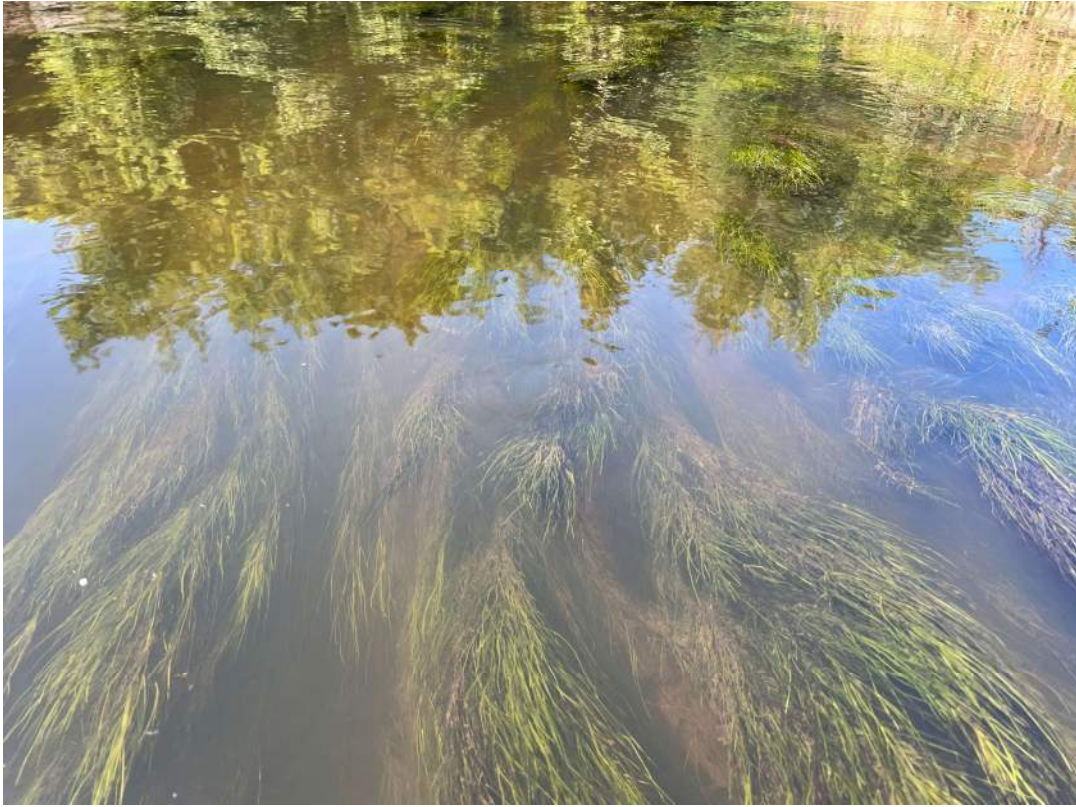
Photo 4: Second type of submerged aquatic vegetation located approximately 80-feet west (upstream) of the Park River Conduit (Segment 1).

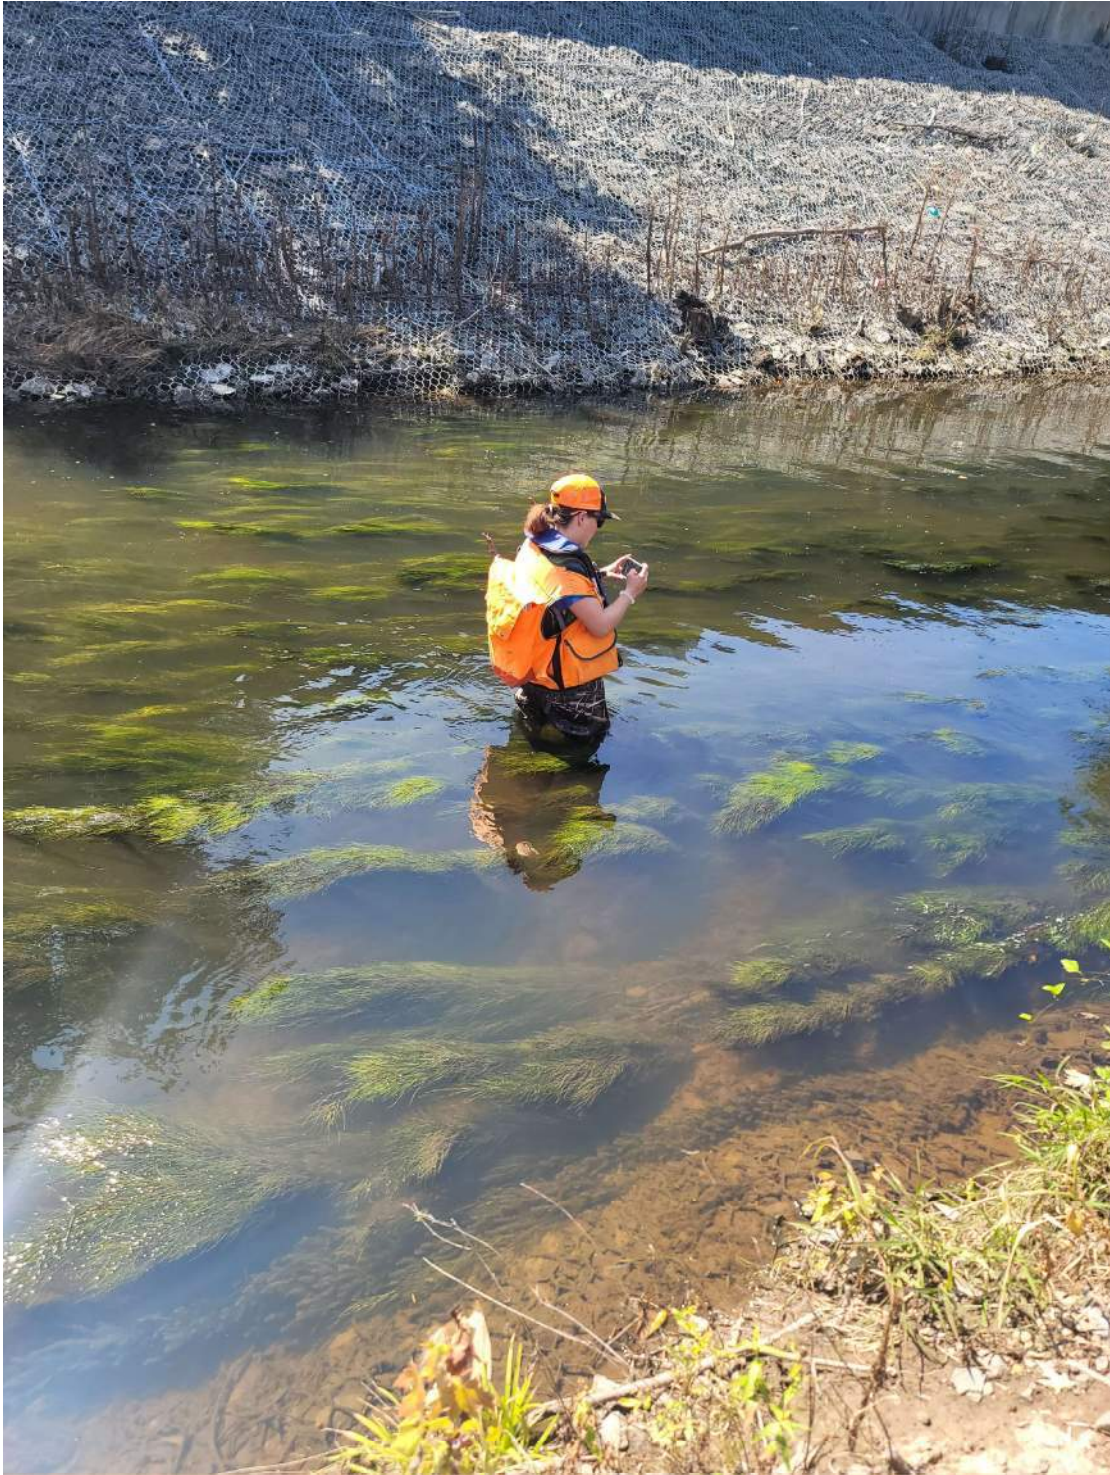
Photo 5: Segment 1 with chain link fence over rip rap armoring.

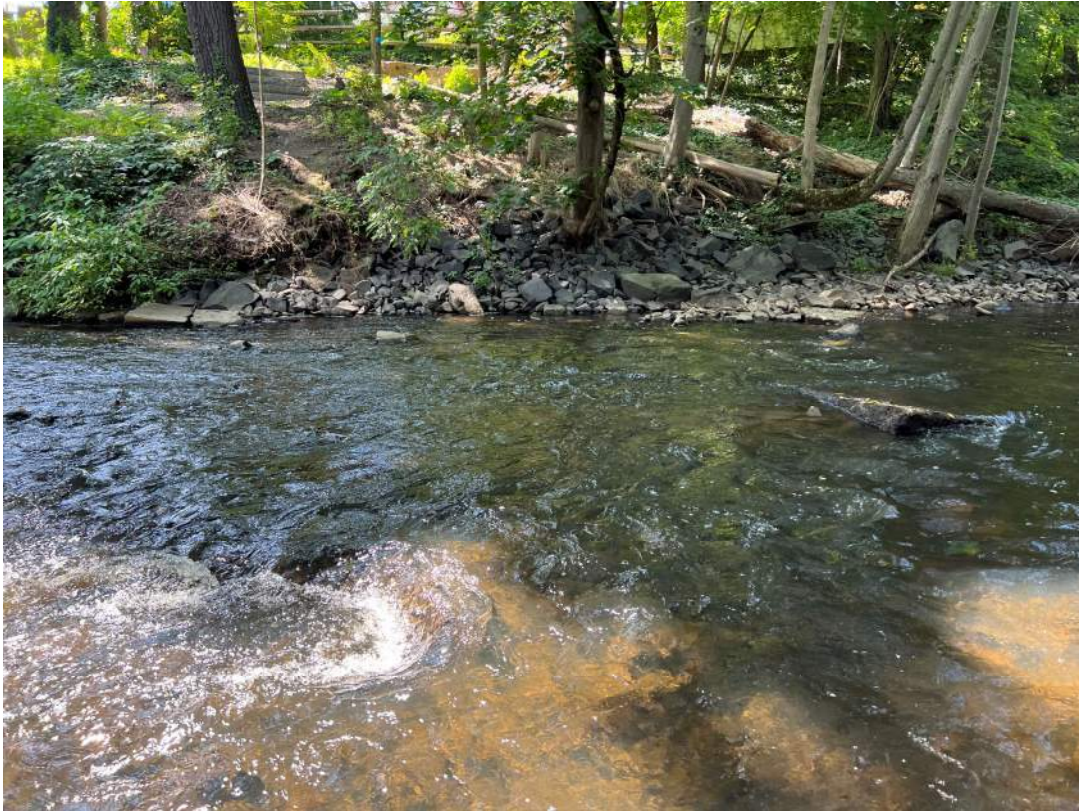
Photo 6: Small-gauge rip rap/naturalized rock channel with areas of riffles and runs and vegetated, gently sloping banks (Segment 1).

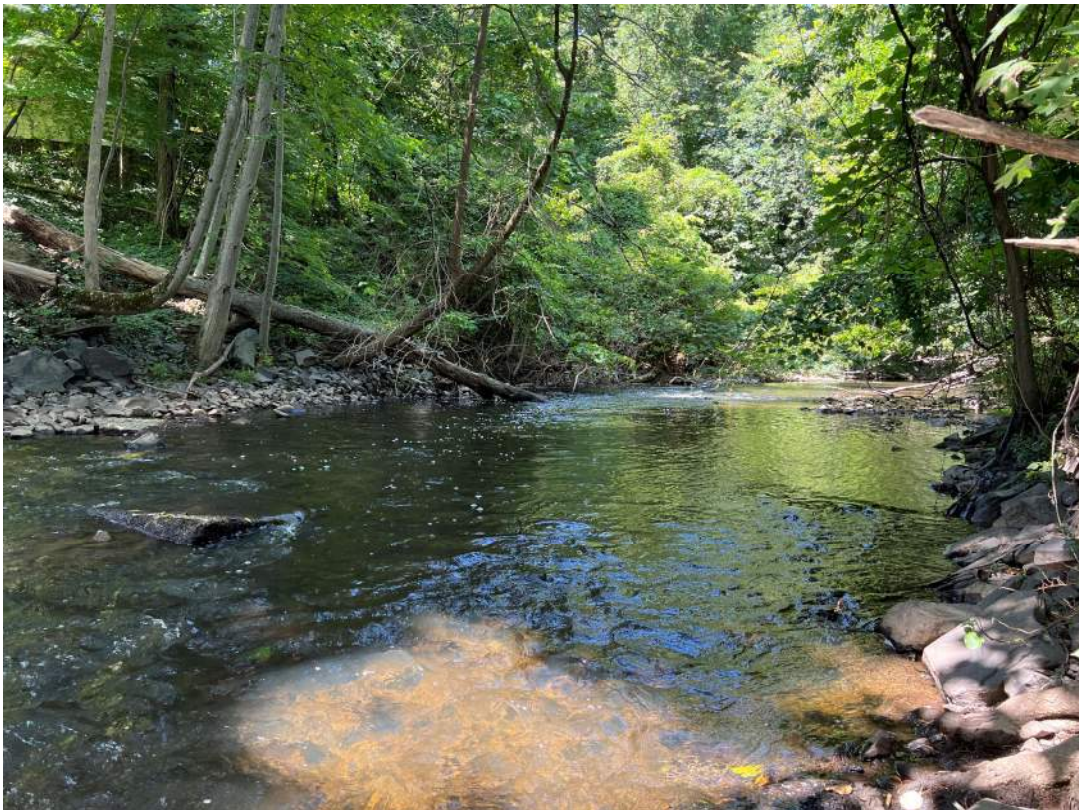
Photo 7: Adjacent to GPS S1DP2, depicting typical river conditions in first portion of Segment 1.

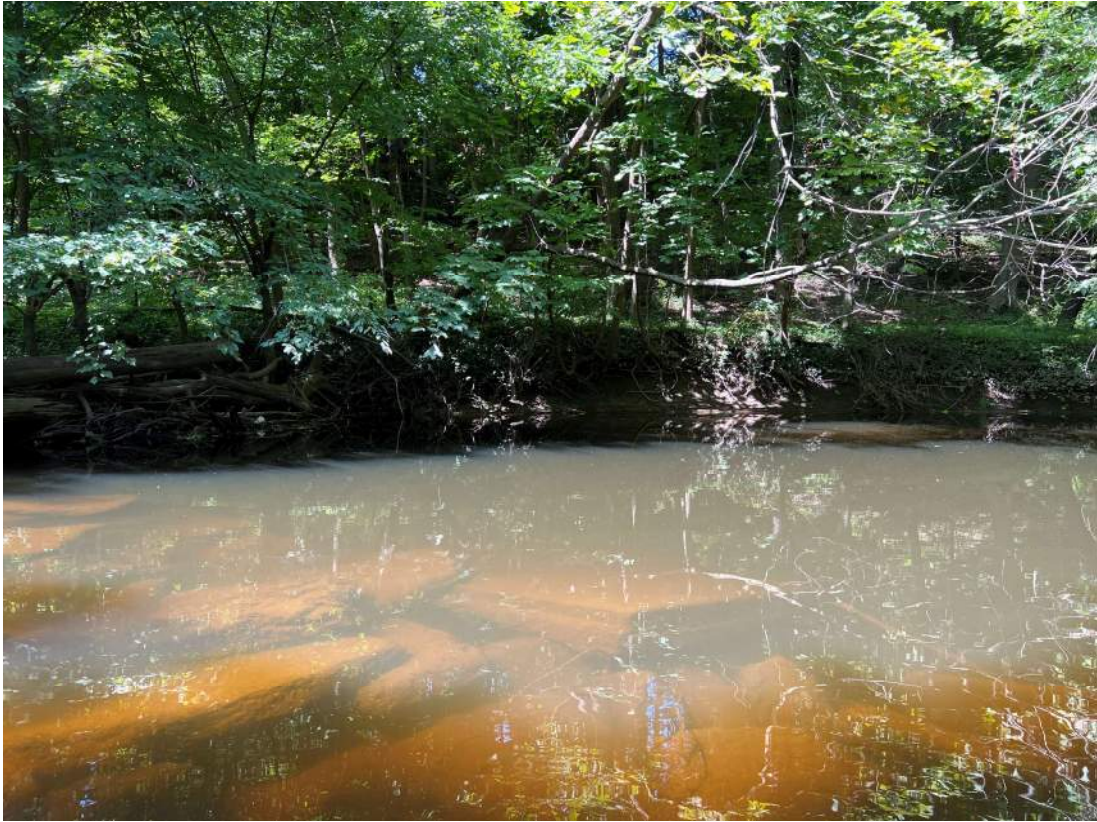
Photo 8: Adjacent to S1DP3, facing west. Large boulders appear placed on bottom, vertical exposed/eroded banks.

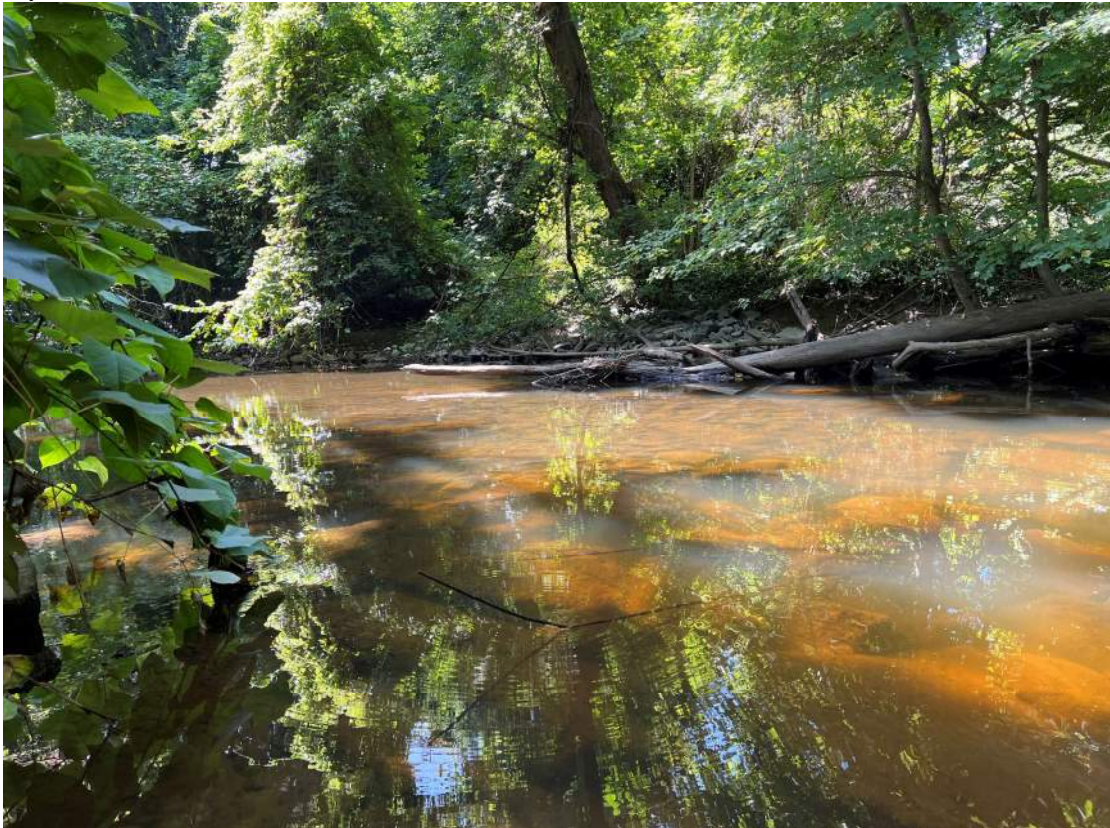
Photo 9: S1DP3 facing south, trees in river in Segment 1 (see Figure 3-1, TD-2).

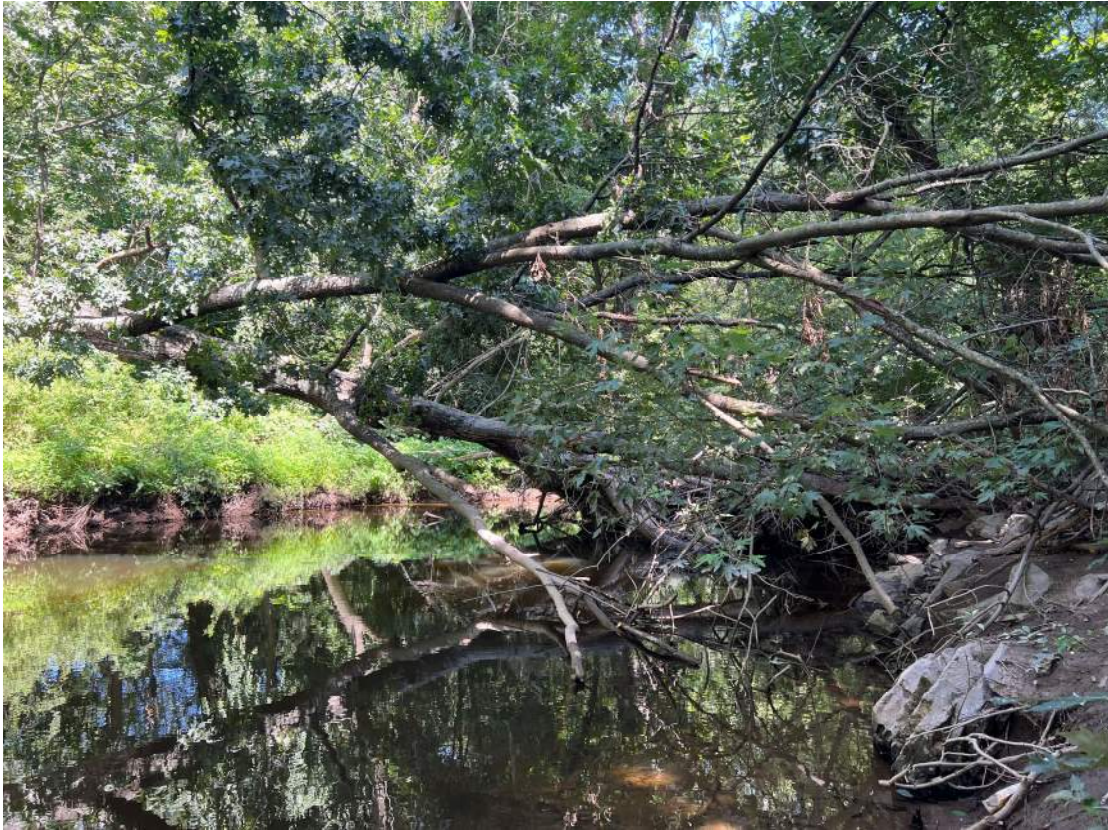
Photo 10: Debris dam behind 21 Woodland Street within Segment 1 (See Figure 3-1, TD-3).

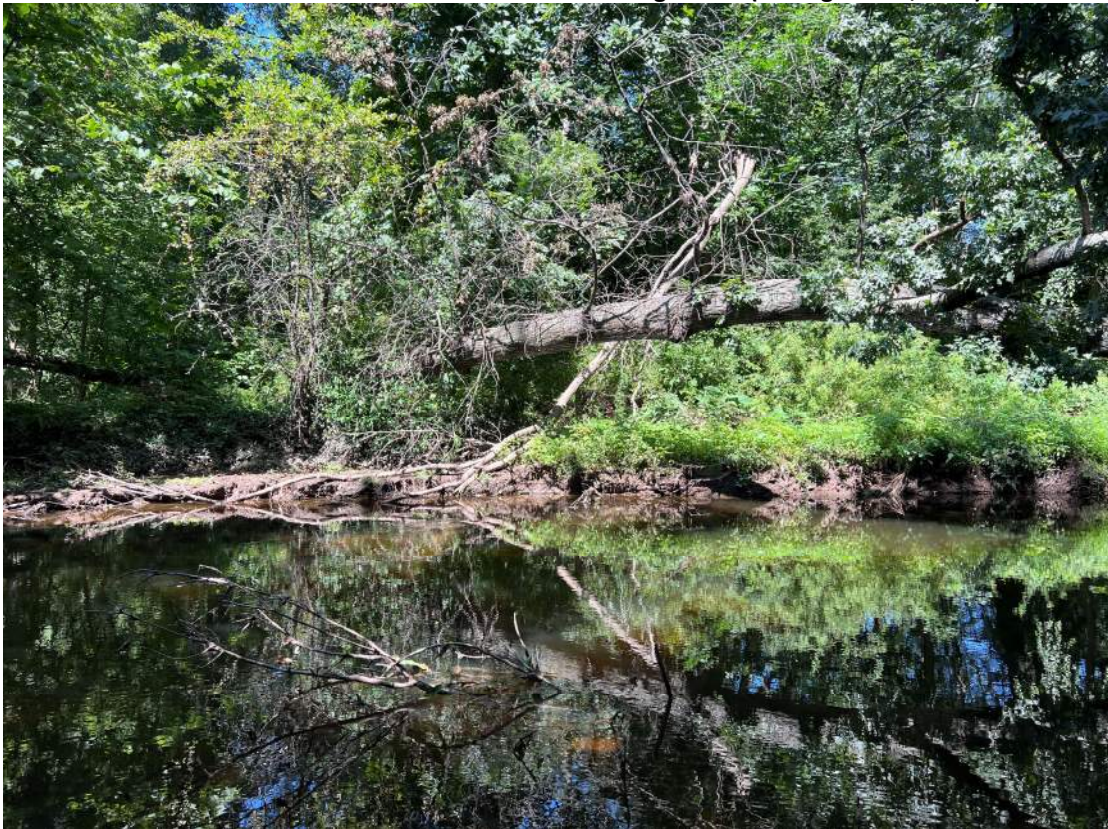
Photo 11: Downed tree and debris dam behind 21 Woodland Street (Segment 1).

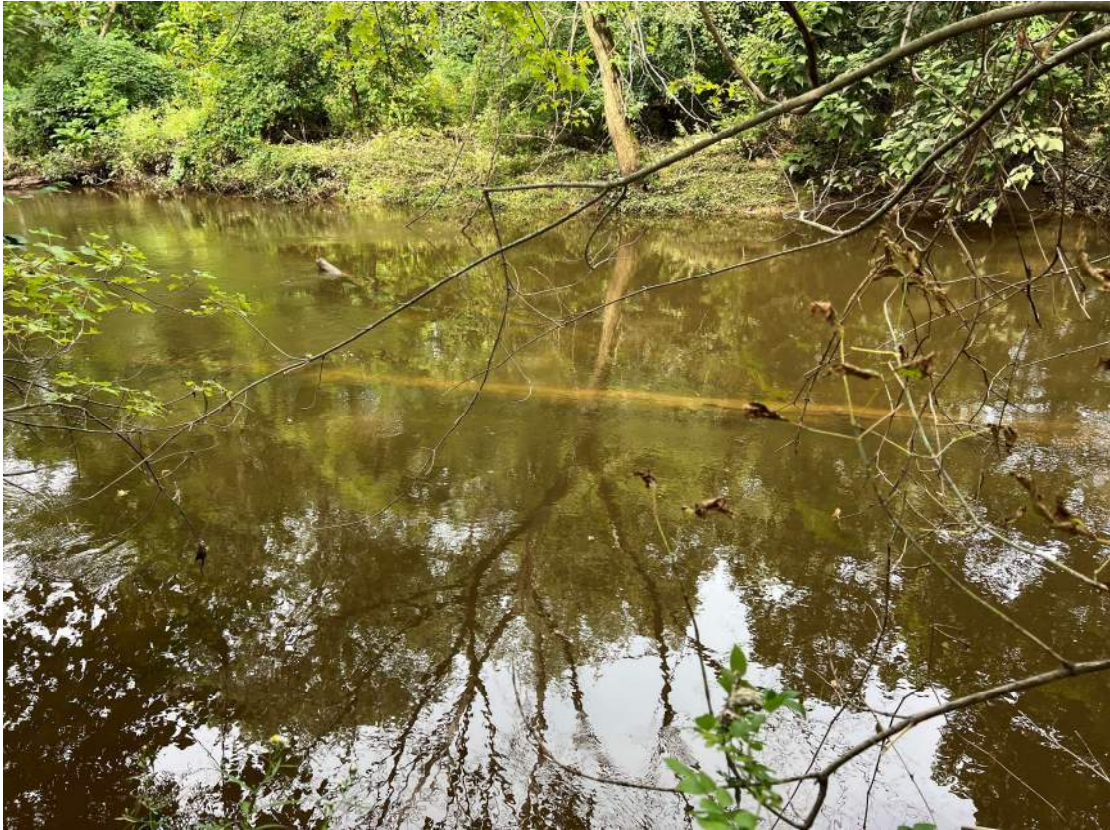
Photo 12: Tree debris within river Segment 2 (see Figure 3-2, TD-5).

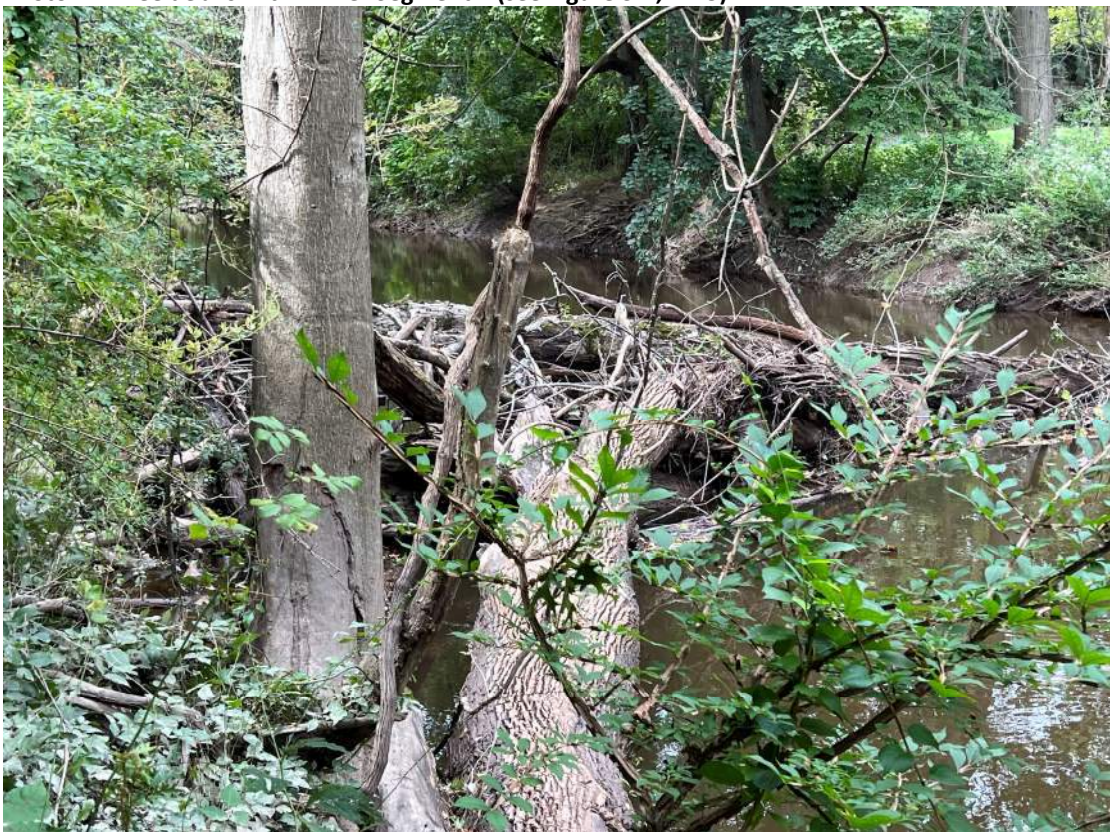
Photo 13: One of many areas of downed trees in Segment 2 (see Figure 3-2, TD-6).

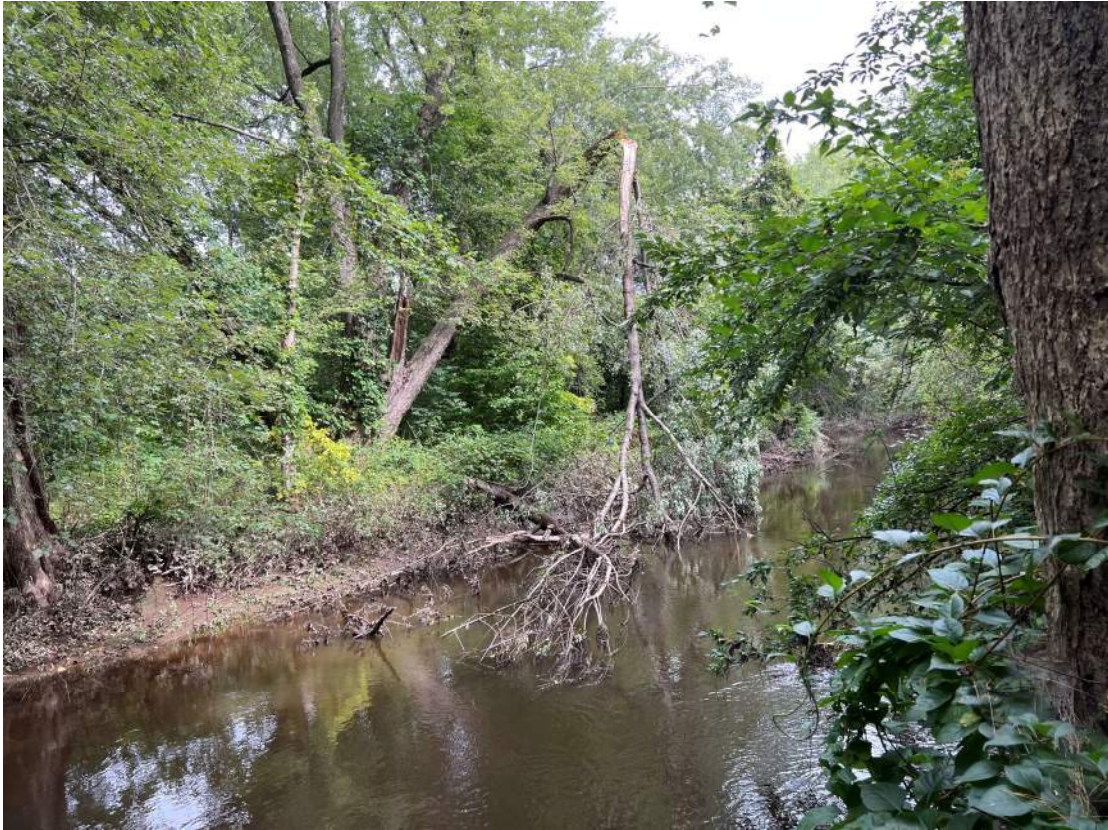
Photo 14: Tree debris in river in Segment 2 (see Figure 3-2, TD-7).

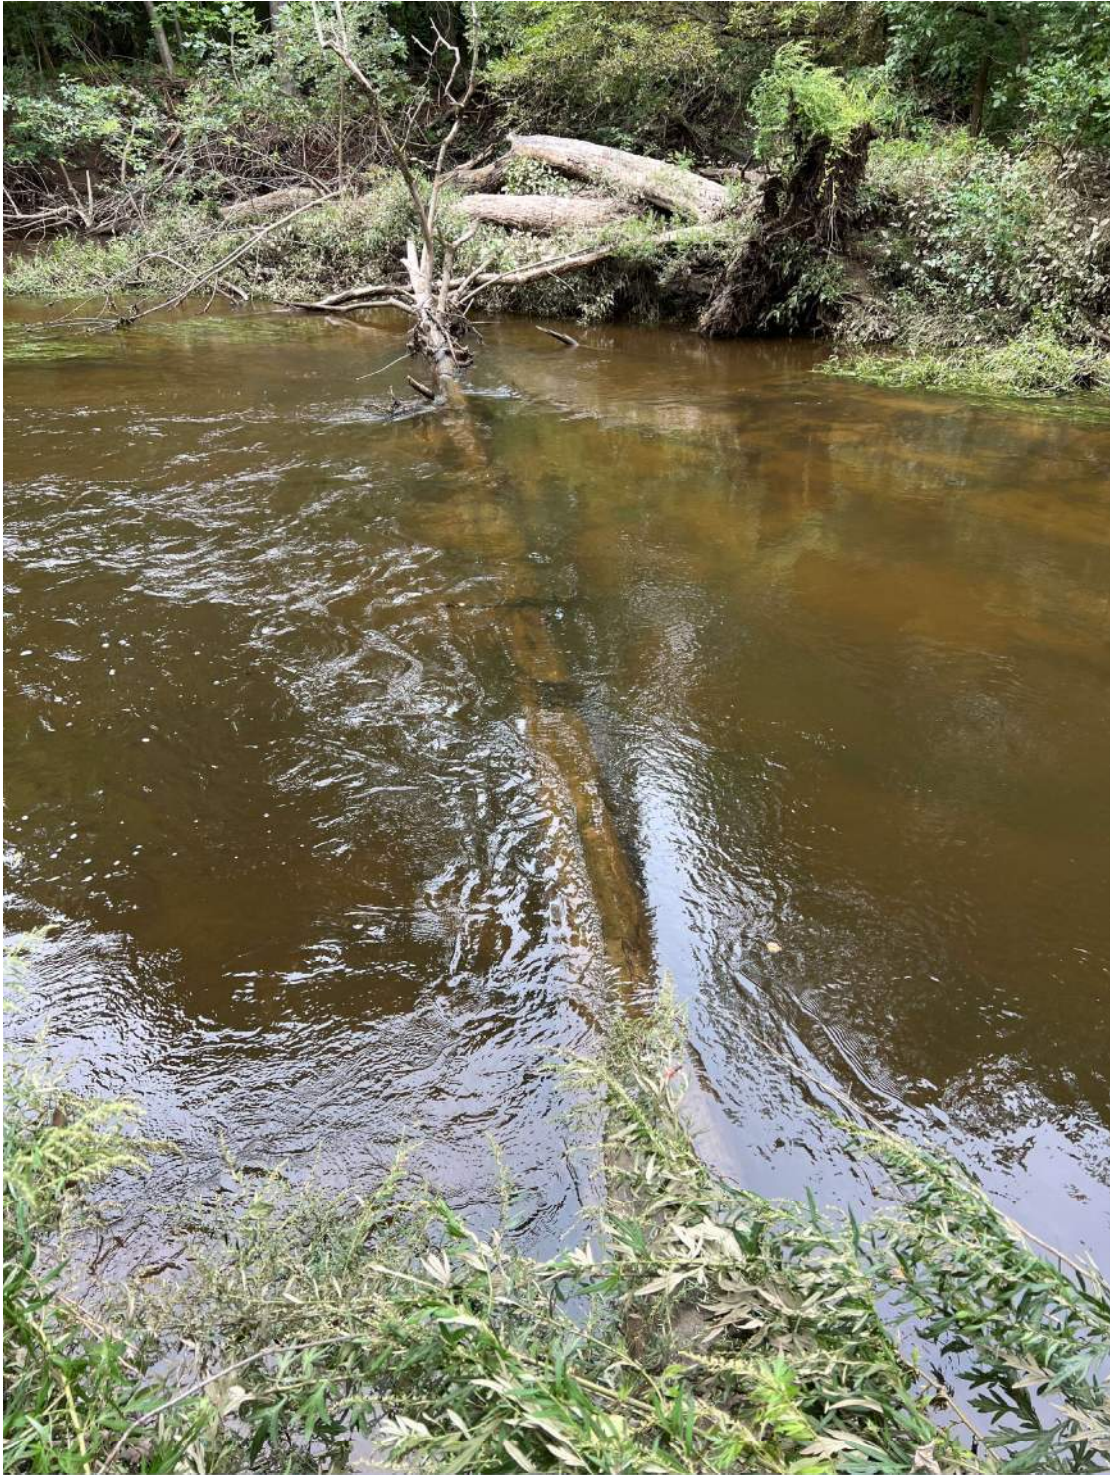
Photo 15: Downed tree within Segment 2, in both main channel and on braided channel at top of photo (see Figure 3-2, TD-8).

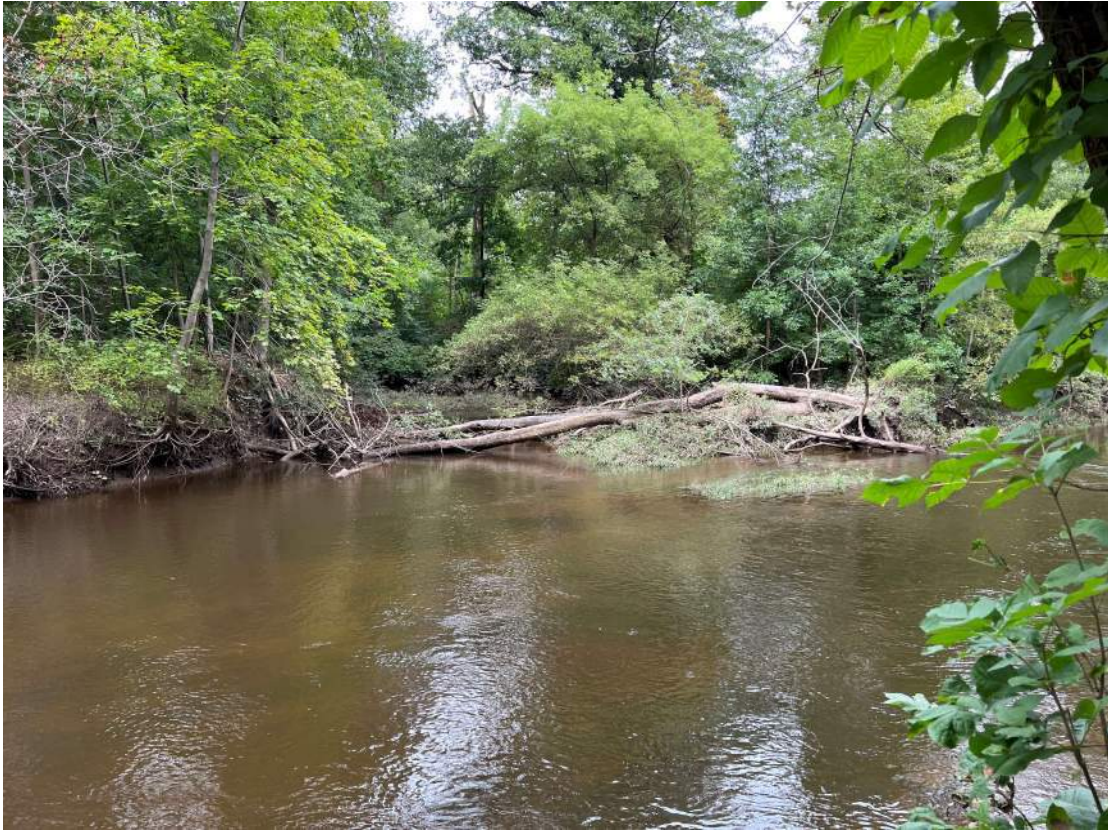
Photo 16: The river becomes a braided channel north of Woodside Circle, and converges back to a single channel west of 129 Woodland Street (Segment 2, see Figure 3-2, TD-8).

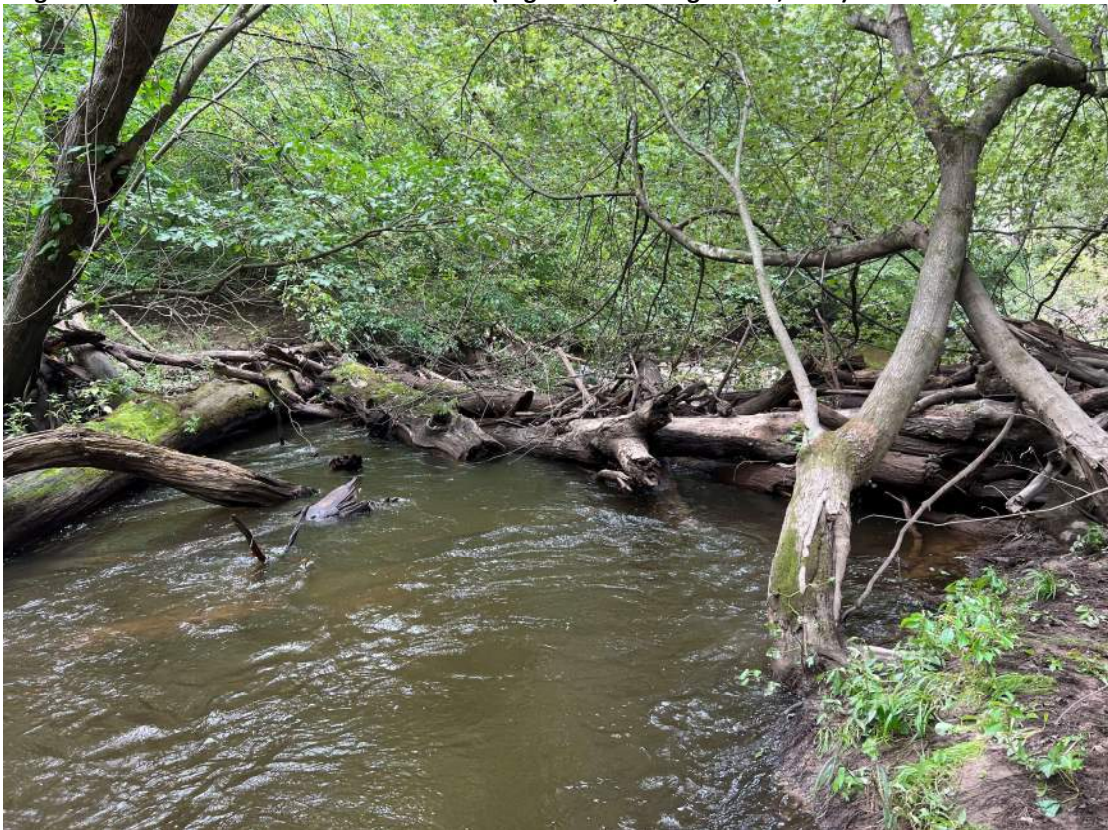
Photo 17: Tree dam downstream of dam looking west (Segment 2, see Figure 3-2, TD-9).

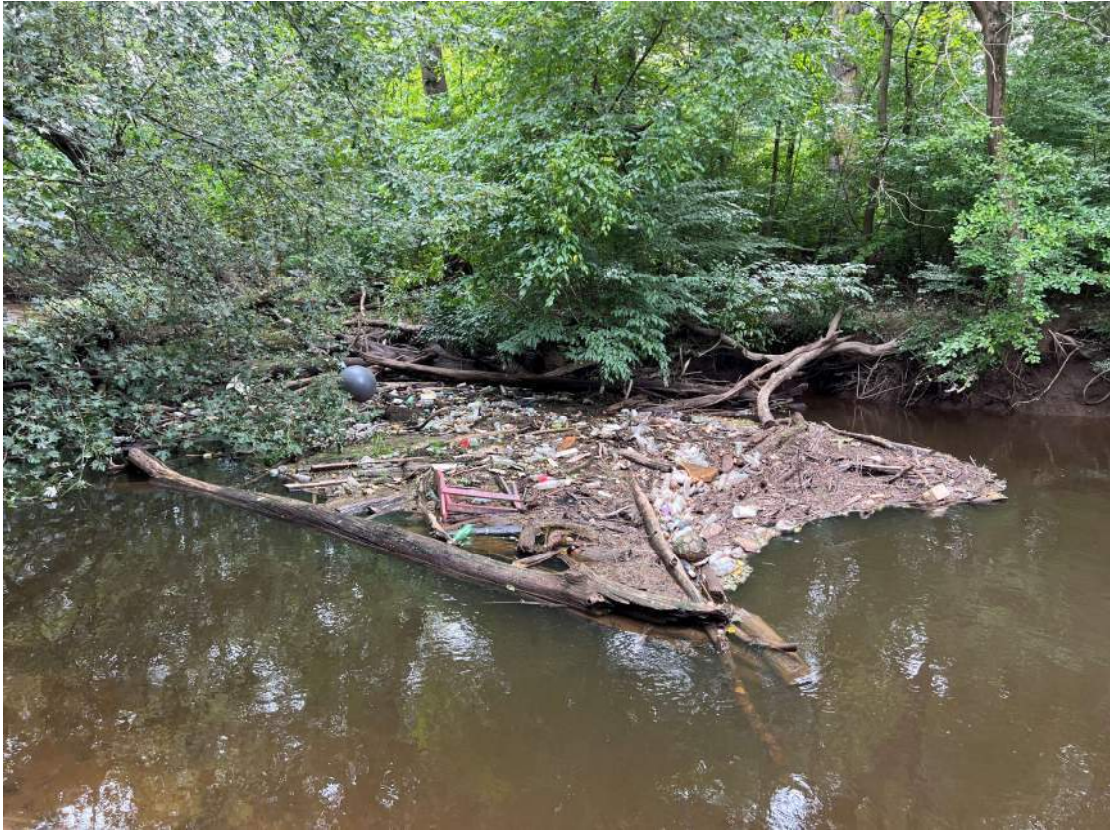
Photo 18: Tree dam upstream of dam looking southeast (Segment 2, see Figure 3-2, TD-9).

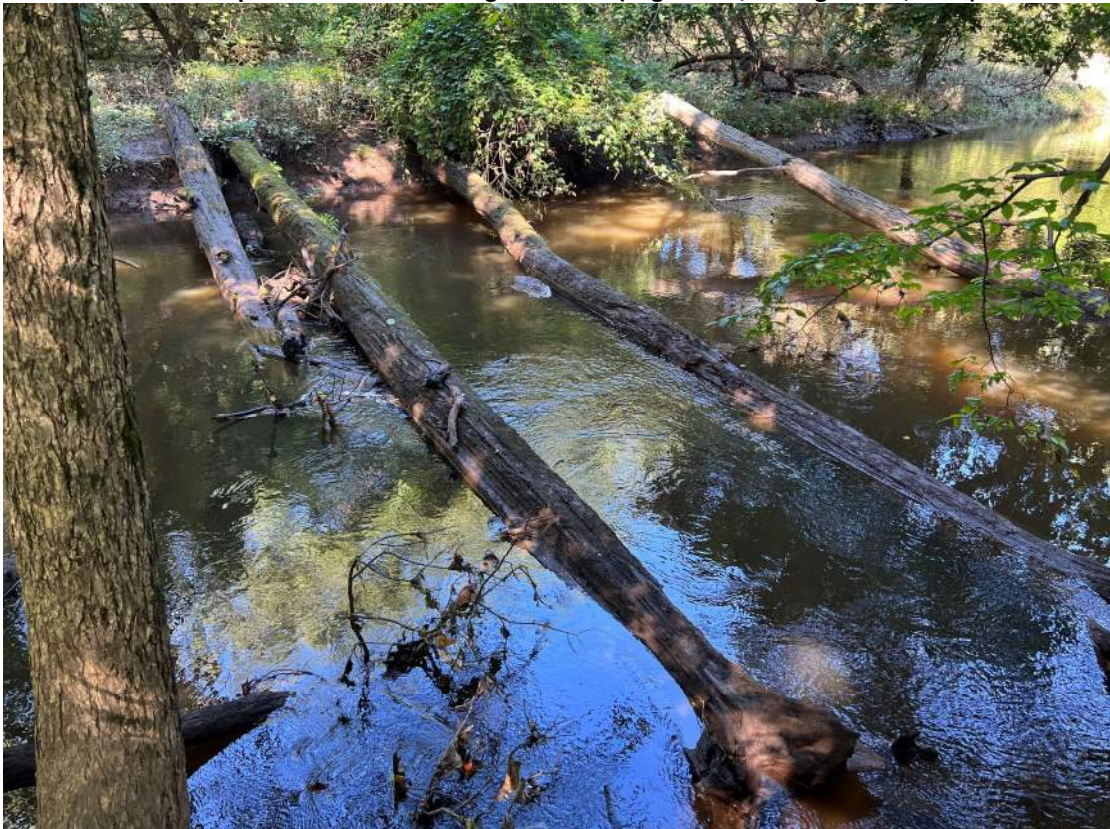
Photo 19: One of many areas of downed trees in Segment 2 (see Figure 3-2, TD-10).

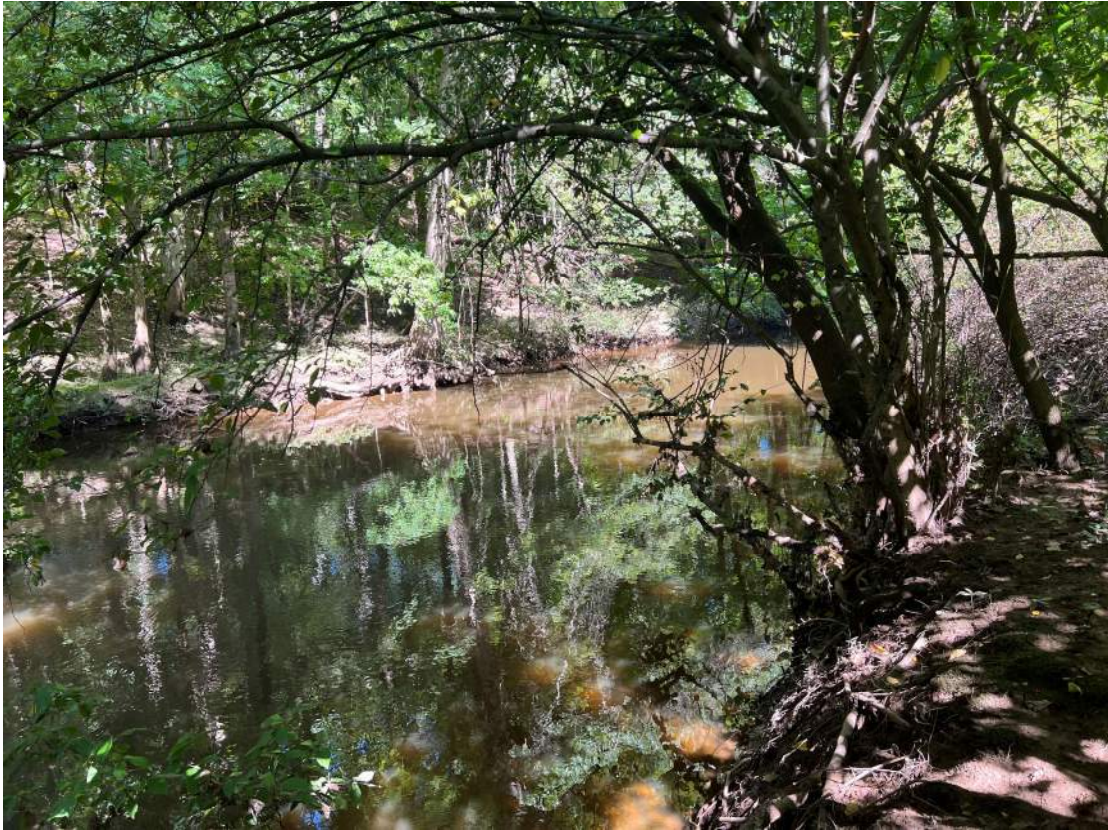
Photo 20: Typical river and bank conditions in Segment 2.

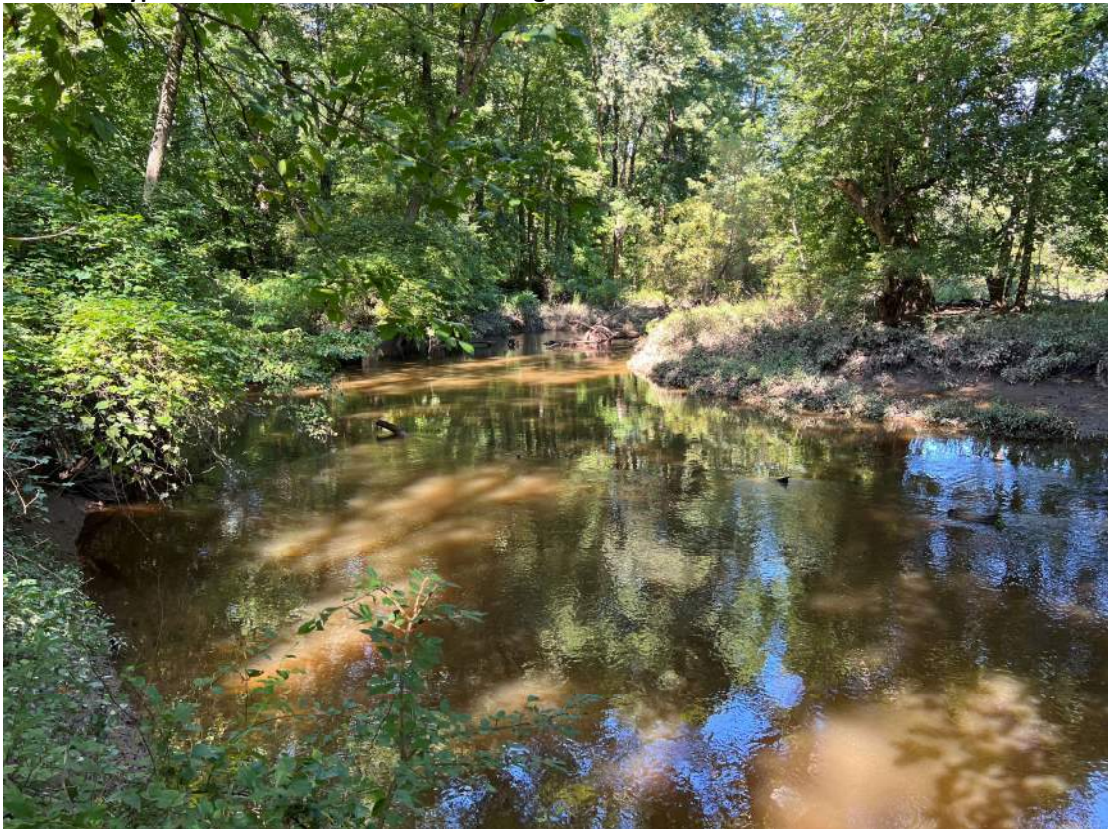
Photo 21: Segment 2 conditions, adjacent to S2DP15.

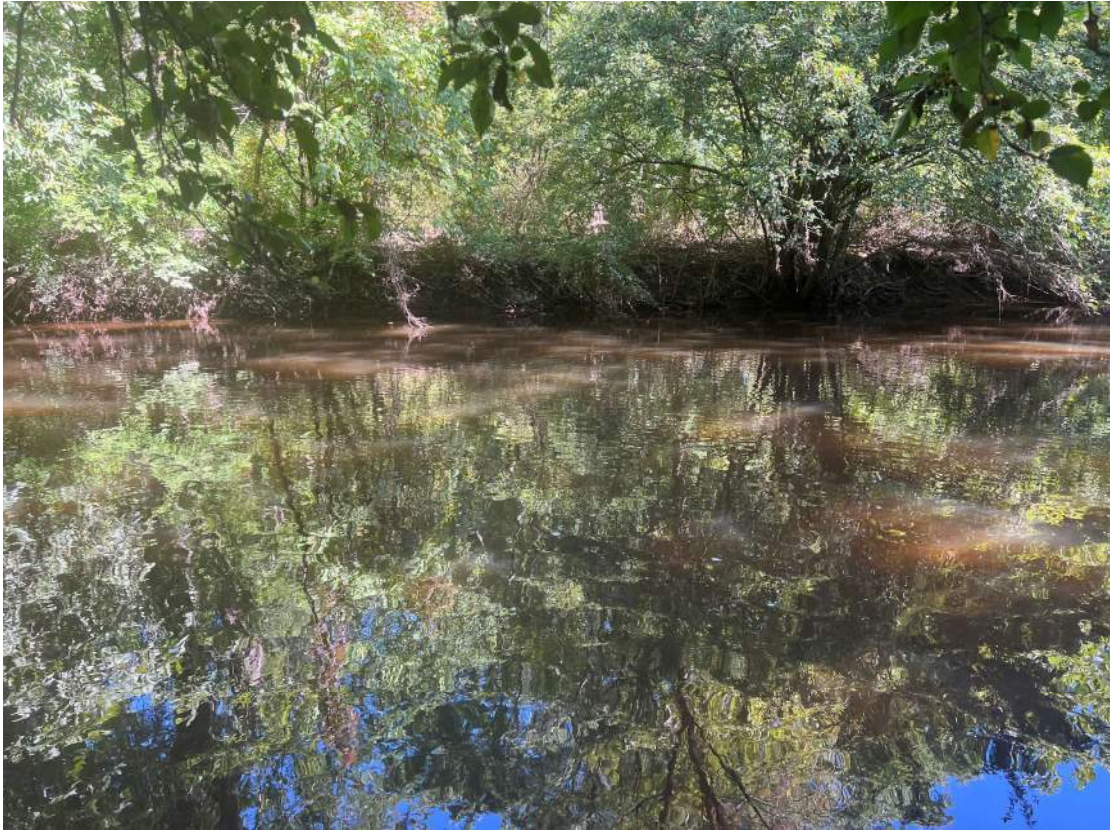
Photo 22: Typical conditions within Segment 3 for first 2/3 of the segment.
