Figure 1. North Branch Park River Study Area Overview
MDC Blue Hills/Granby Drainage Study
North Branch Park River Field Study
Hartford, CT

Attachment A

Site Photographs

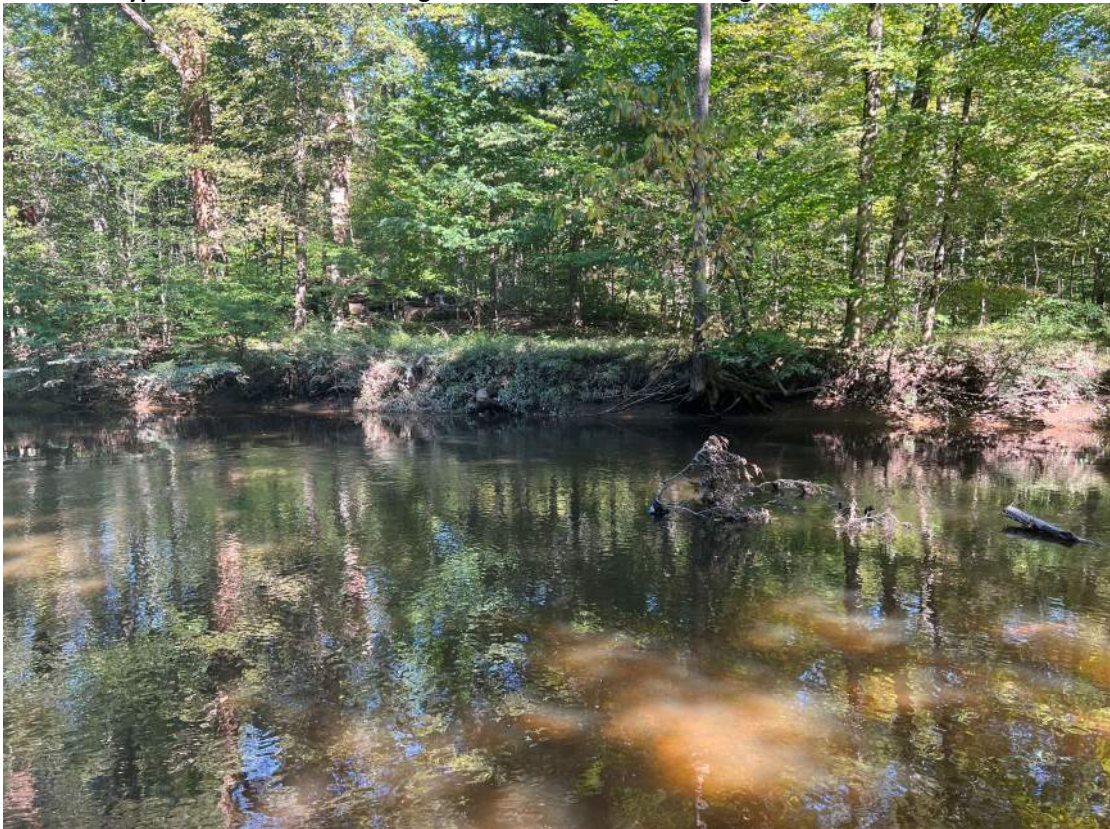
Photo 23: Typical conditions within Segment 3 for first 2/3 of the segment.

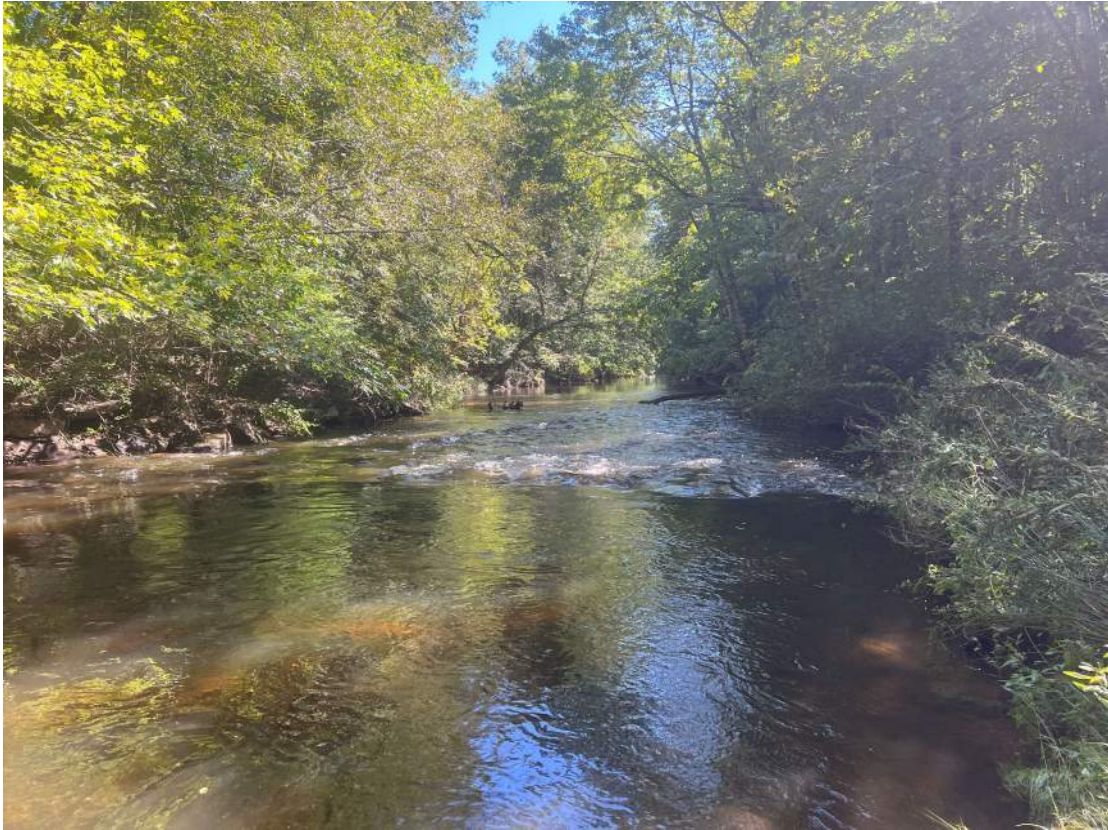
Photo 24: Northernmost portion of Segment 3 where the river becomes shallower and with a higher prevalence of cobble and rock in the riverbed.

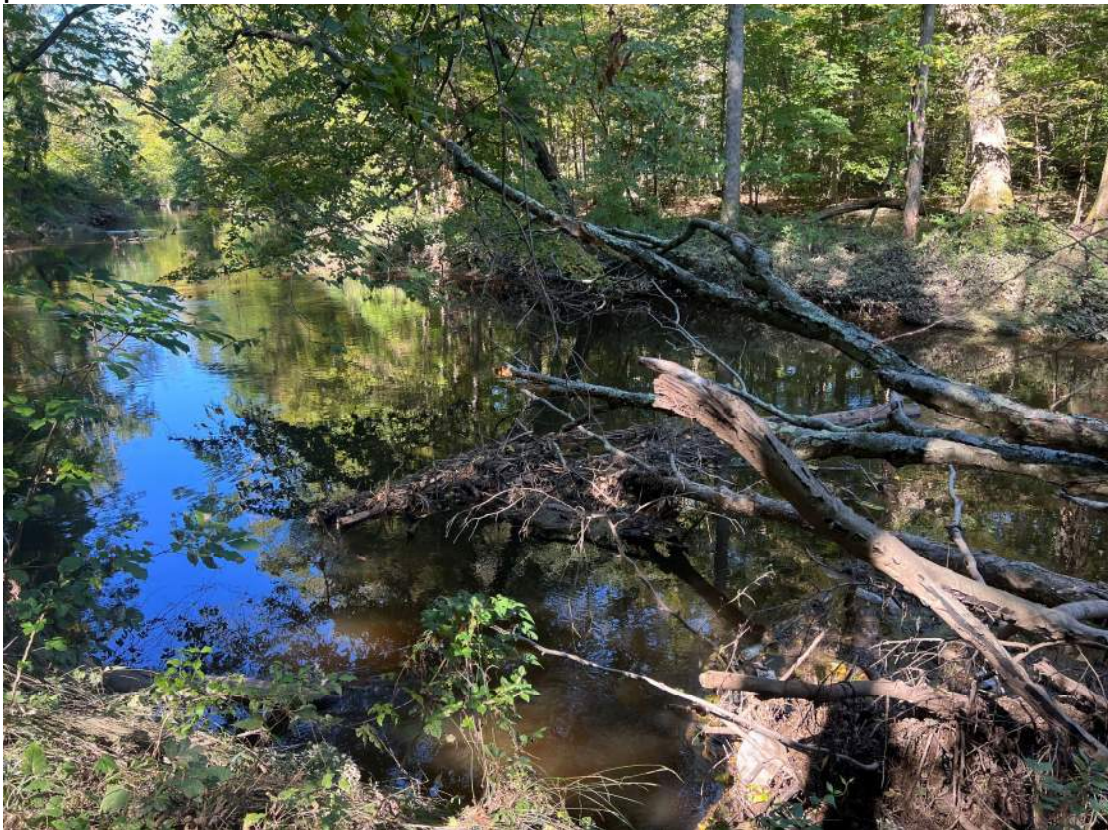
Photo 25: Downed trees, debris dam within Segment 3 (see Figure 3-3, TD-11).

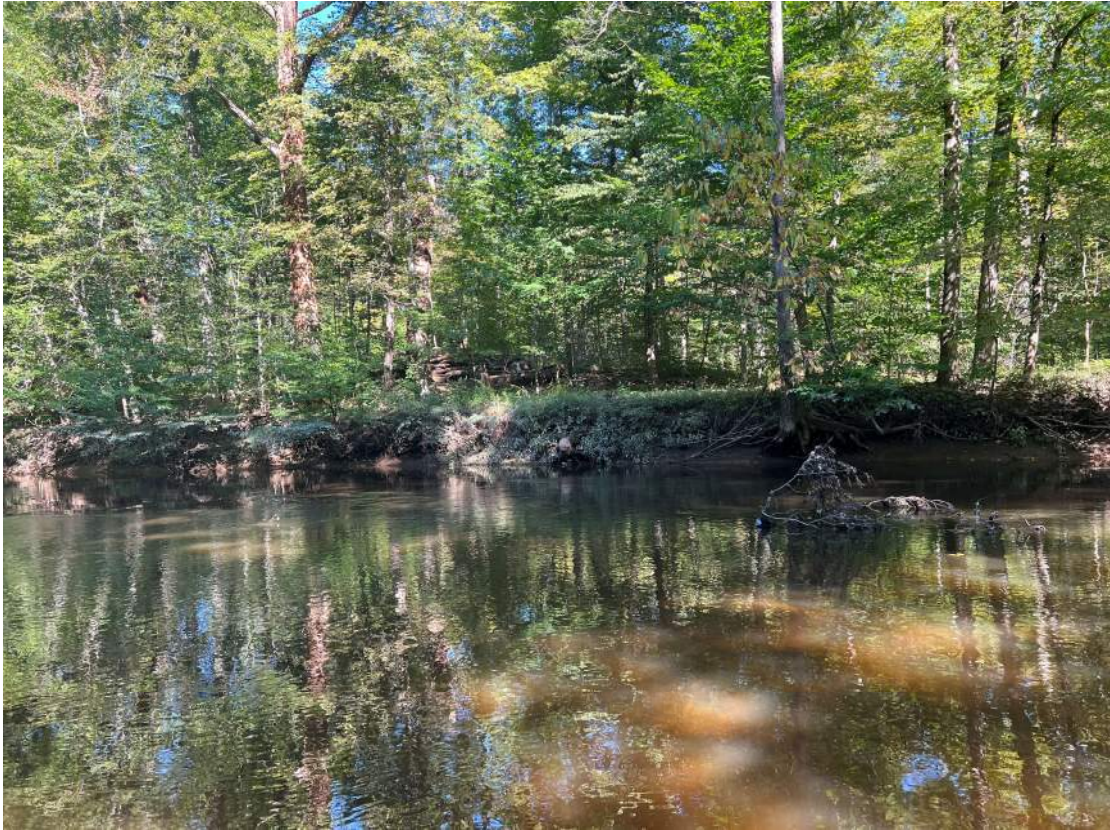
Photo 26: Downed tree debris and near vertical banks in Segment 3 (see Figure 3-3, TD-12).

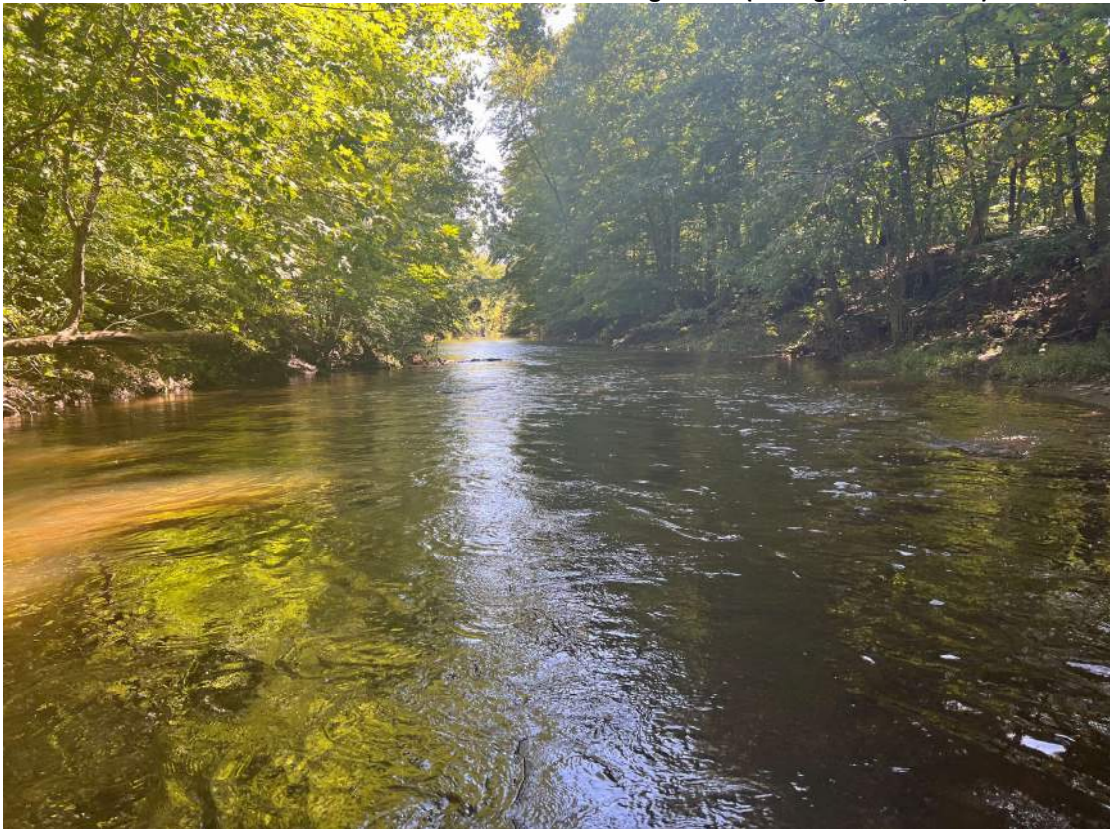
Photo 27: Tree debris in Segment 3 (see Figure 3-3, TD-13).

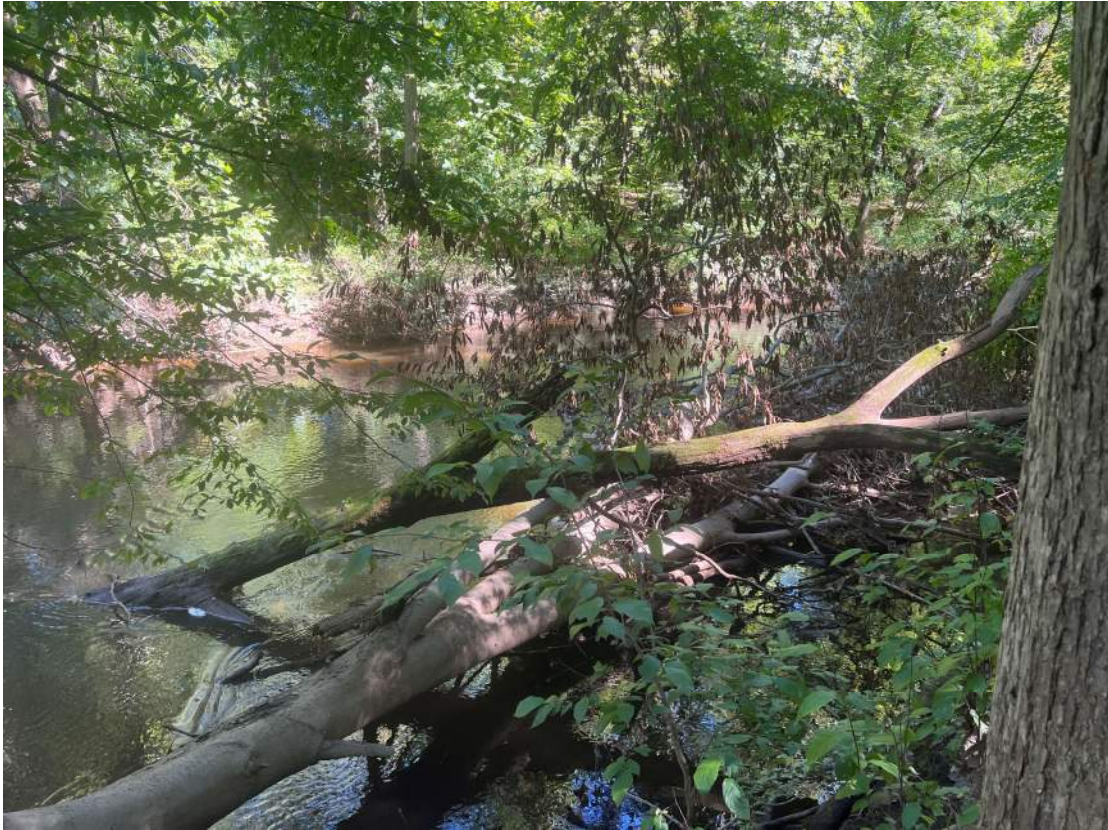
Photo 28: Example of downed trees in Segment 3 (see Figure 3-3, TD-14).

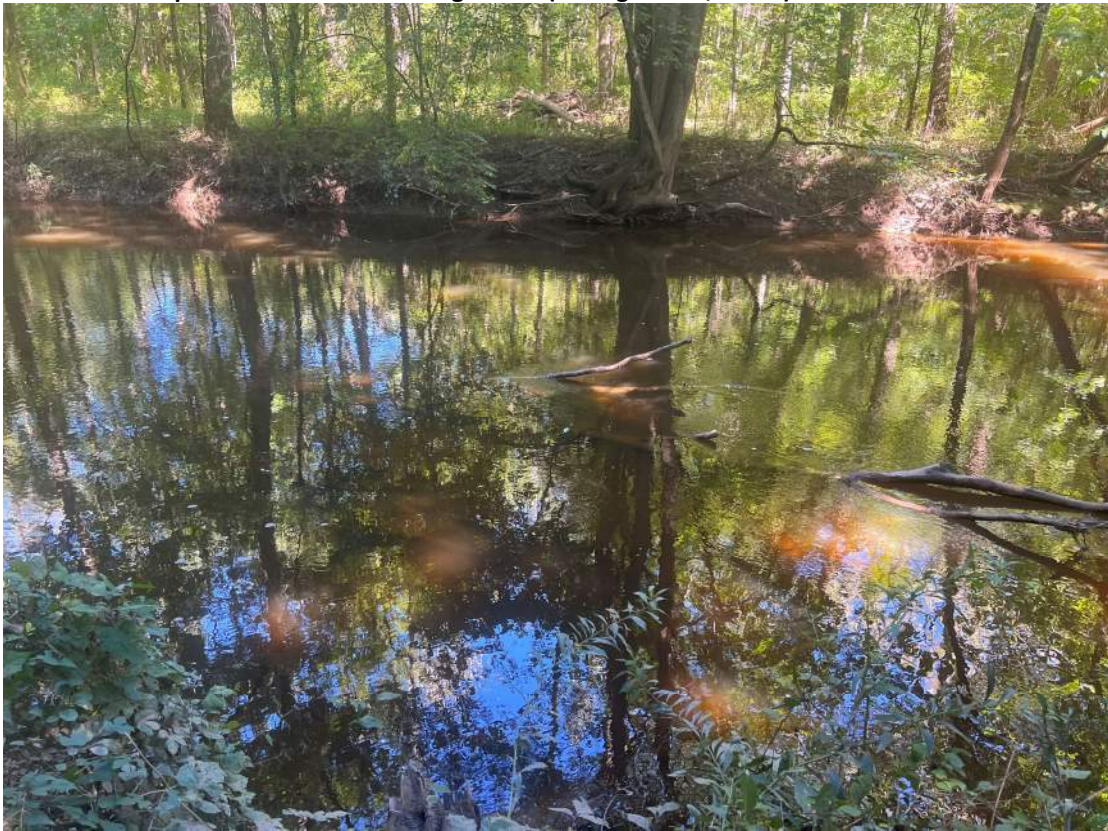
Photo 29: Tree debris and near vertical banks in Segment 3 (see Figure 3-3, TD-15).

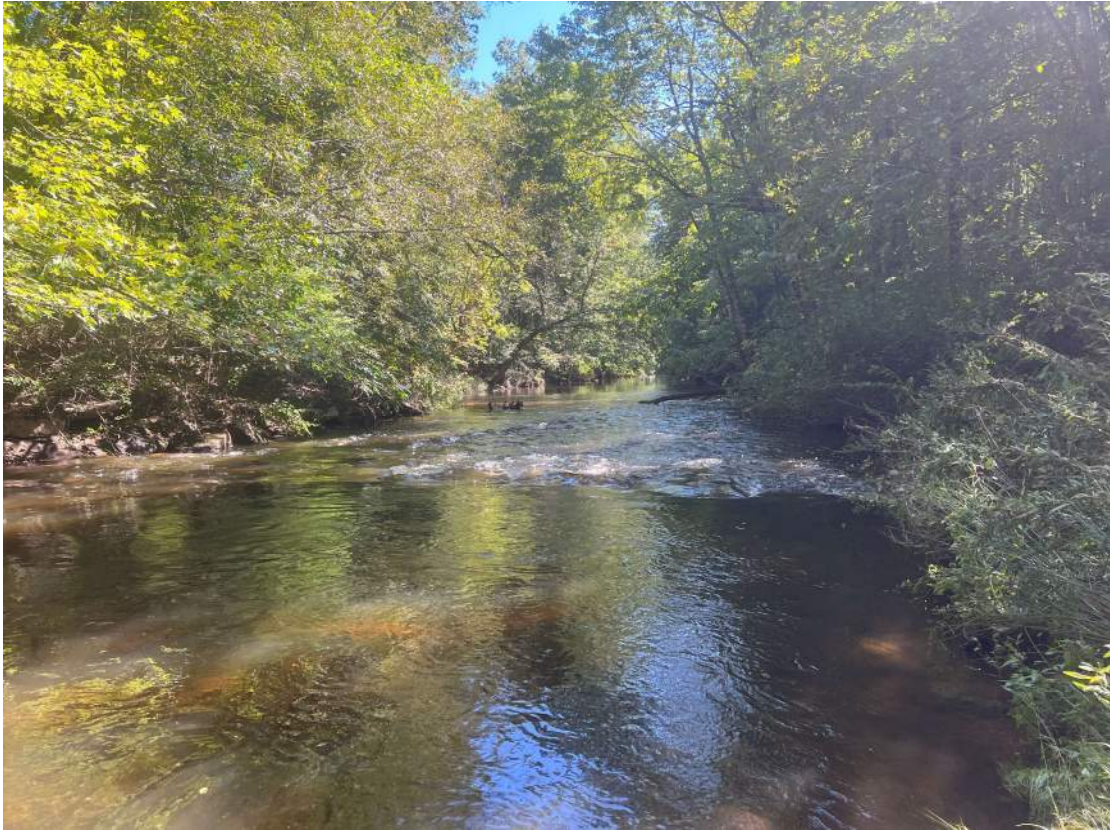
Photo 30: Tree debris in Segment 3 (see Figure 3-3, TD-16).

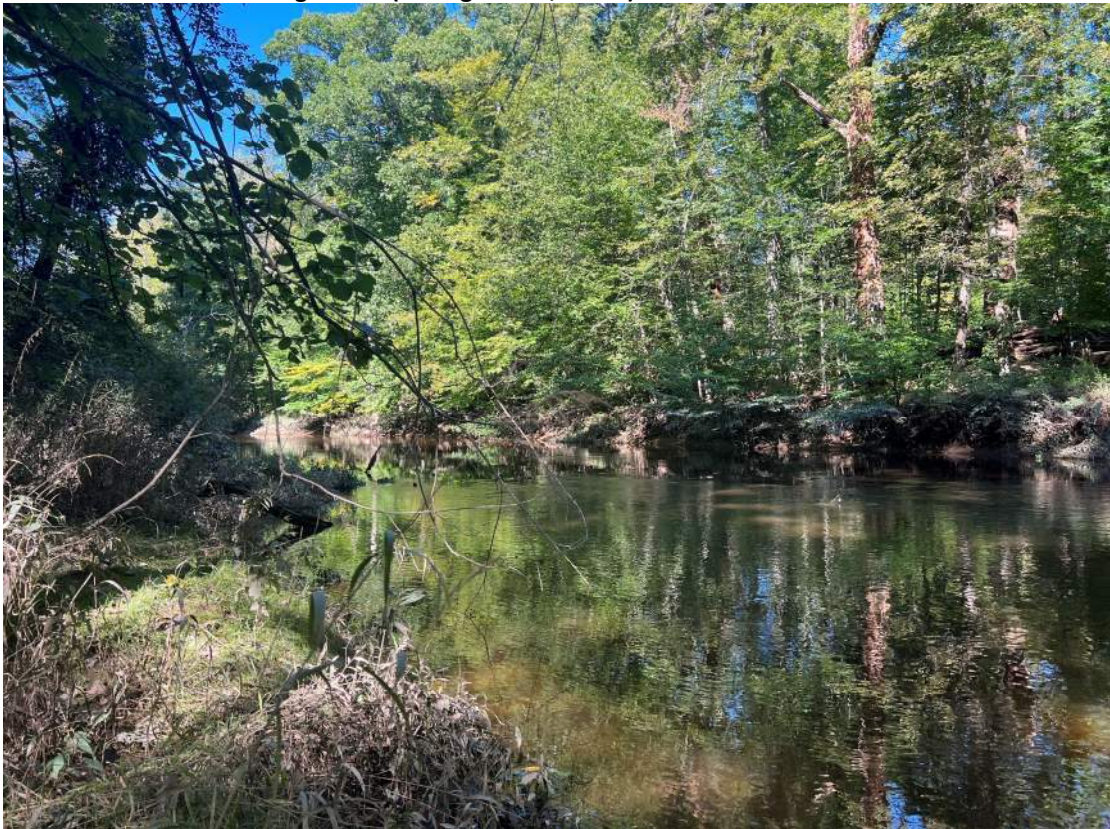
Photo 31: Example of near vertical banks on the opposite bank in Segment 3.

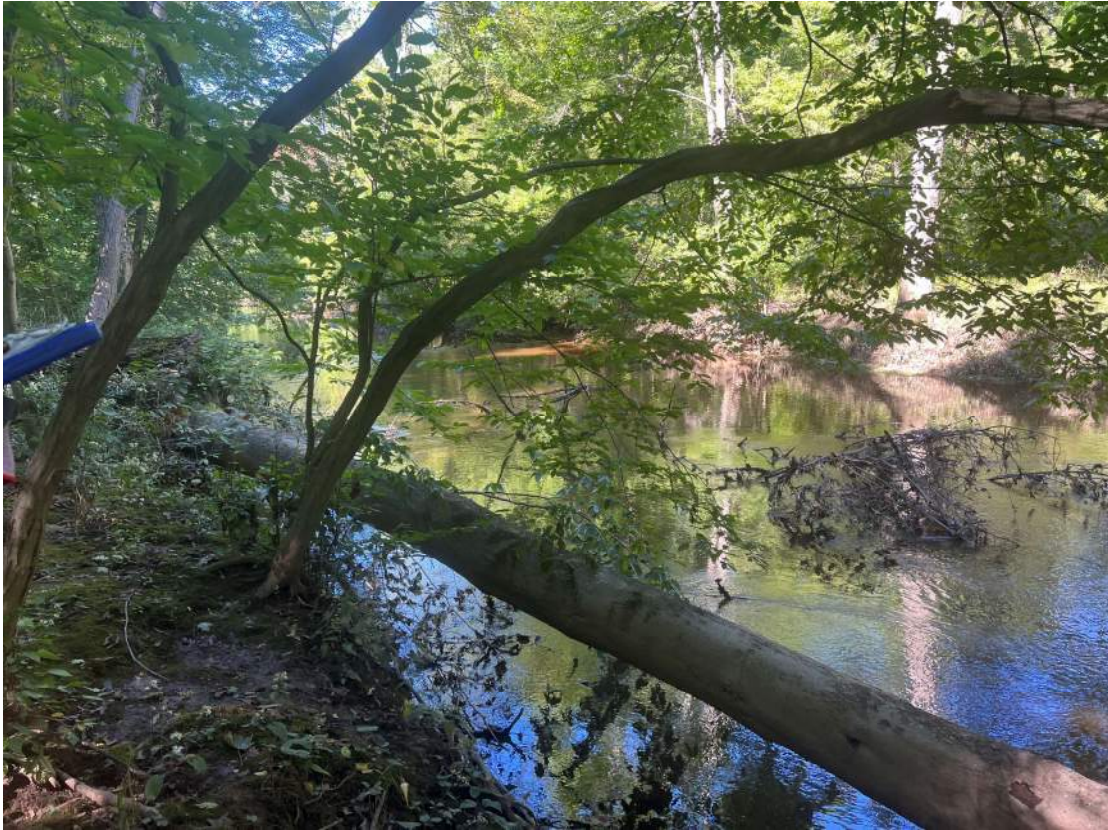
Photo 32: Example of near vertical banks on the opposite bank in Segment 3 (also TD-14 on Figure 3-3).

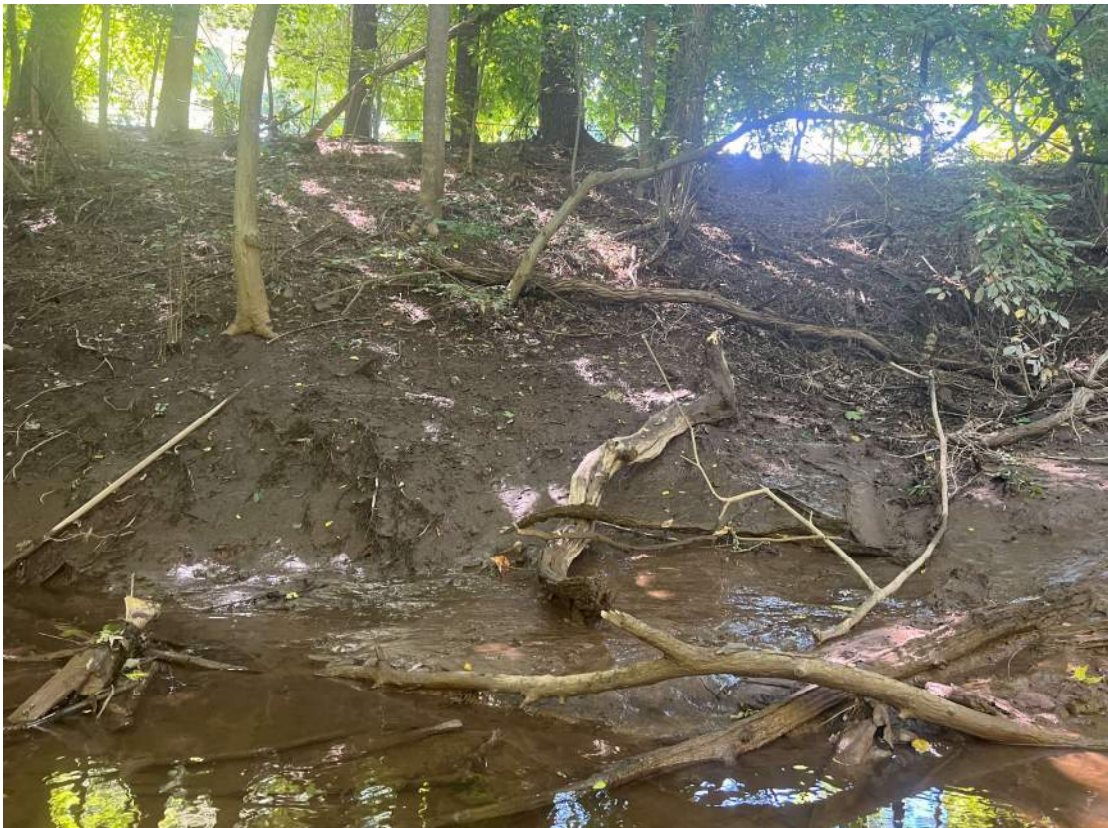
Photo 33: Example of near vertical banks on the opposite bank in Segment 3.

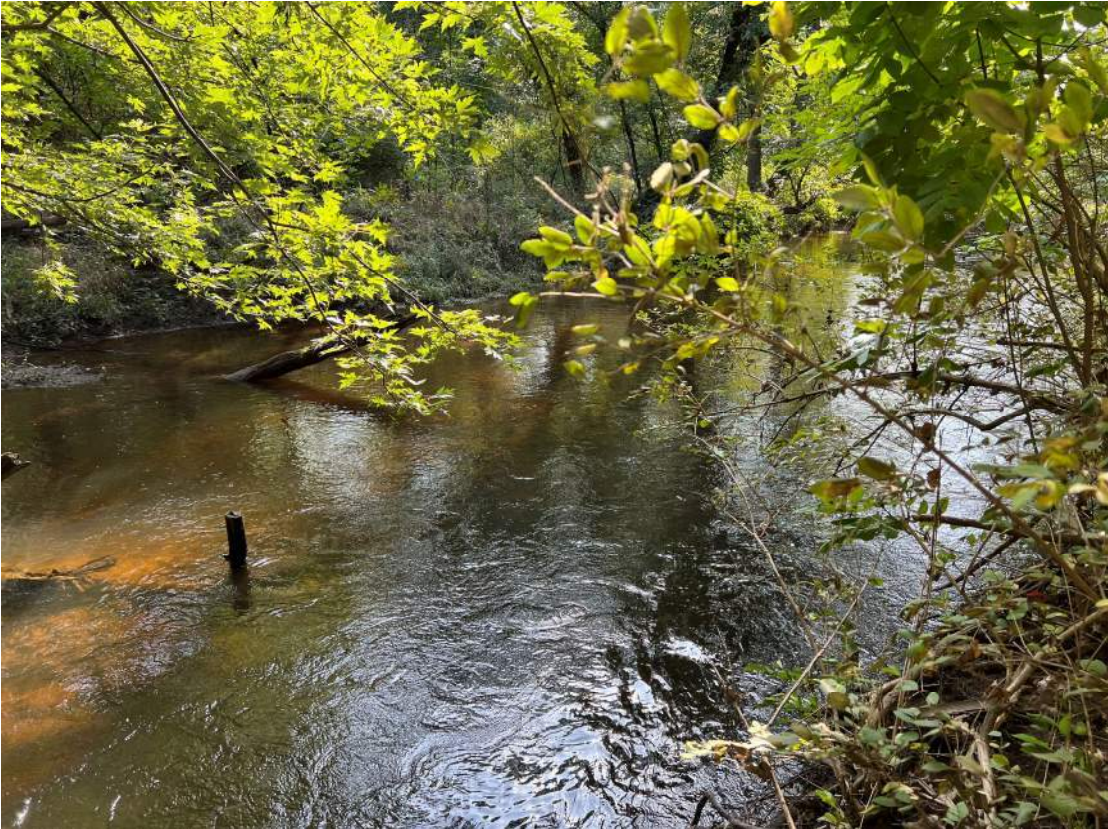
Photo 34: Tree debris within Segment 4 (see Figure 3-4, TD-17).

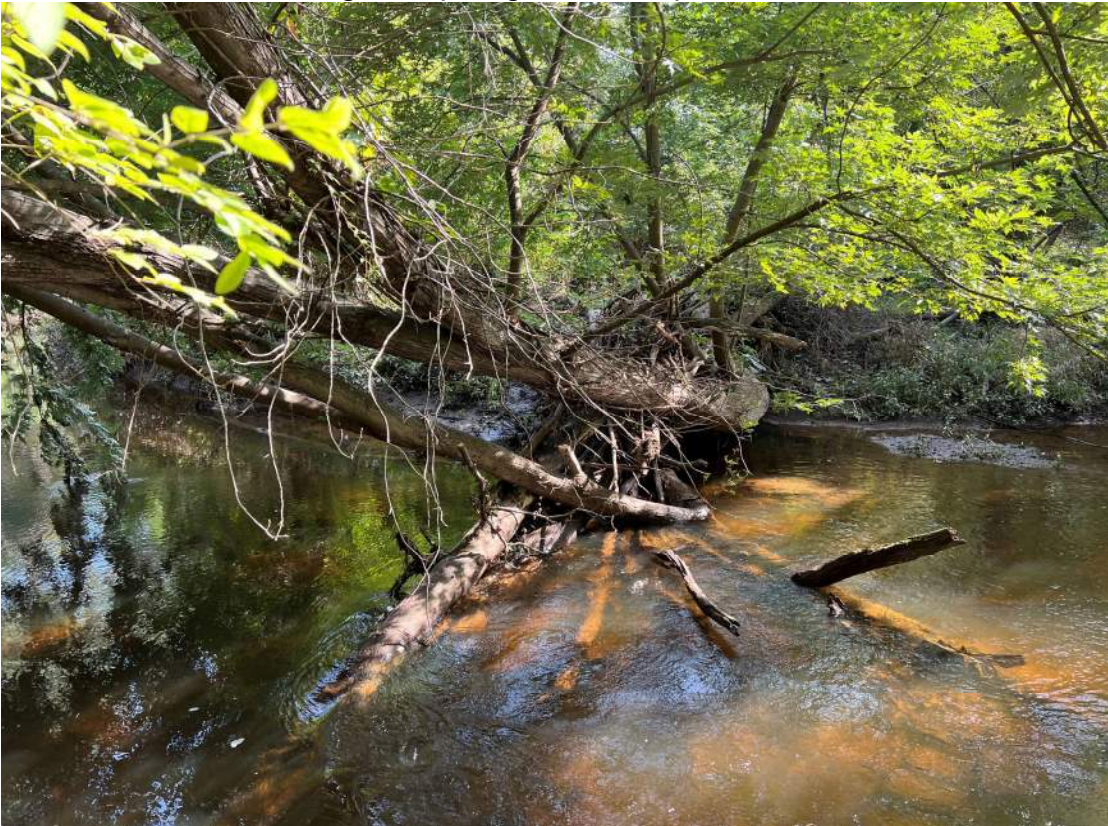
Photo 35: Tree dam within Segment 4 (see Figure 3-4, TD-18).

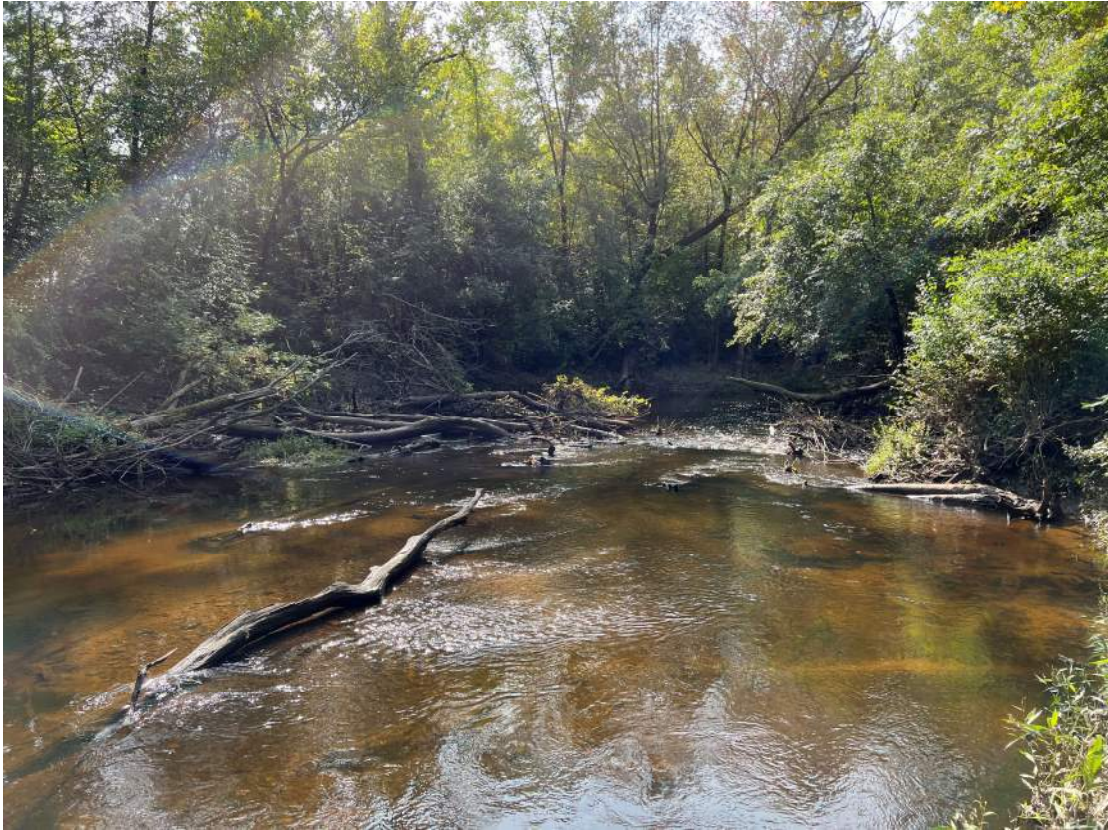
Photo 36: Tree debris/dam in Segment 4 (see Figure 3-4, TD-19).

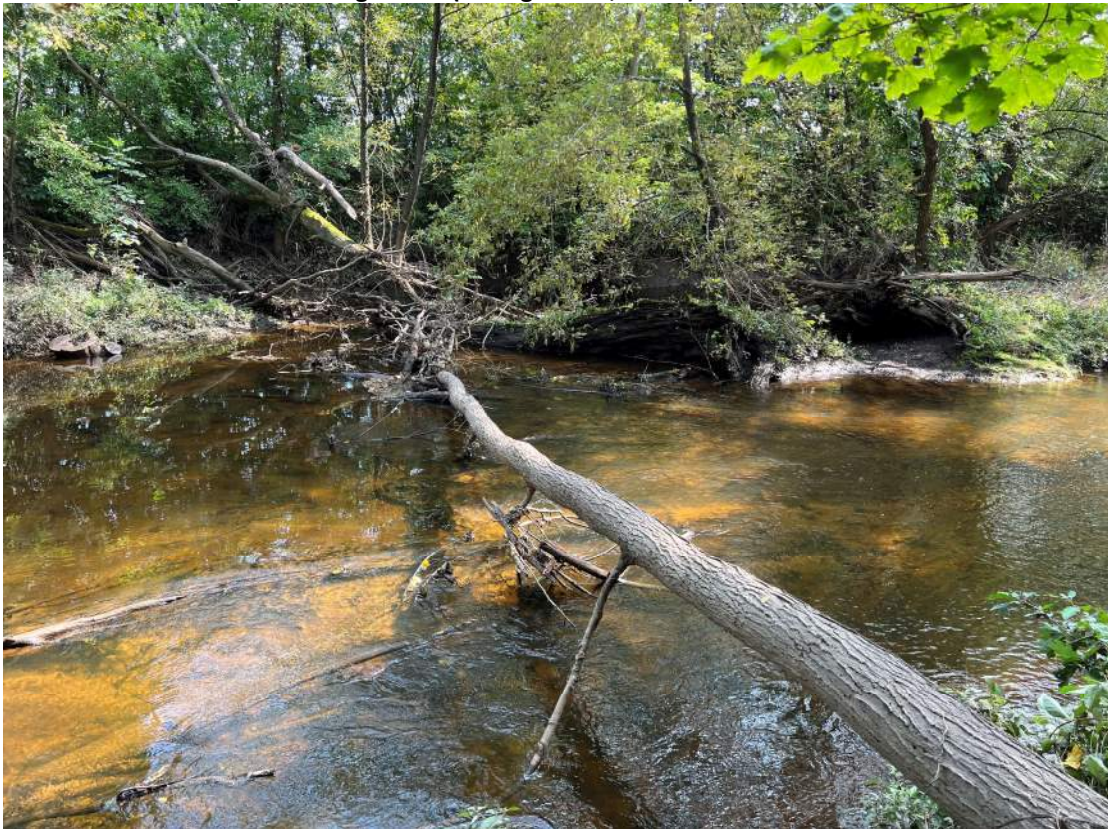
Photo 37: Bank failure conditions, down trees, undercut banks in Segment 4 (see Figure 3-4, TD-20).

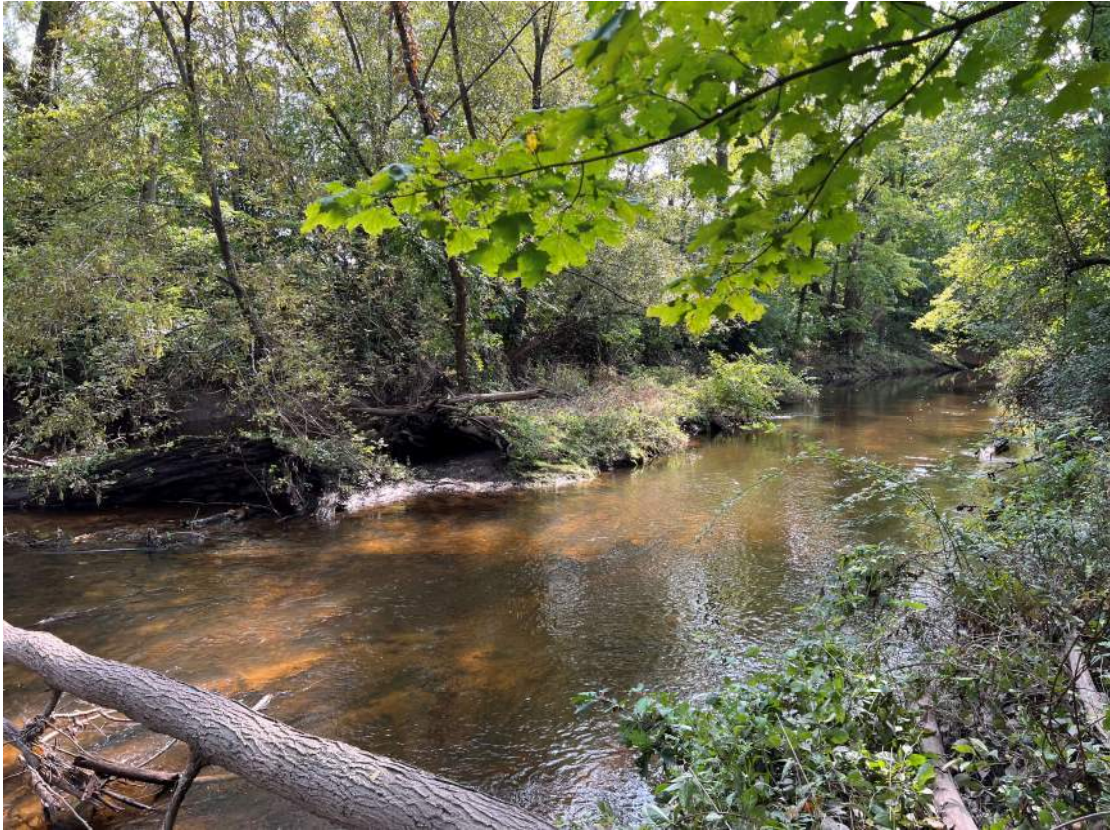
Photo 38: Typical conditions in Segment 4.

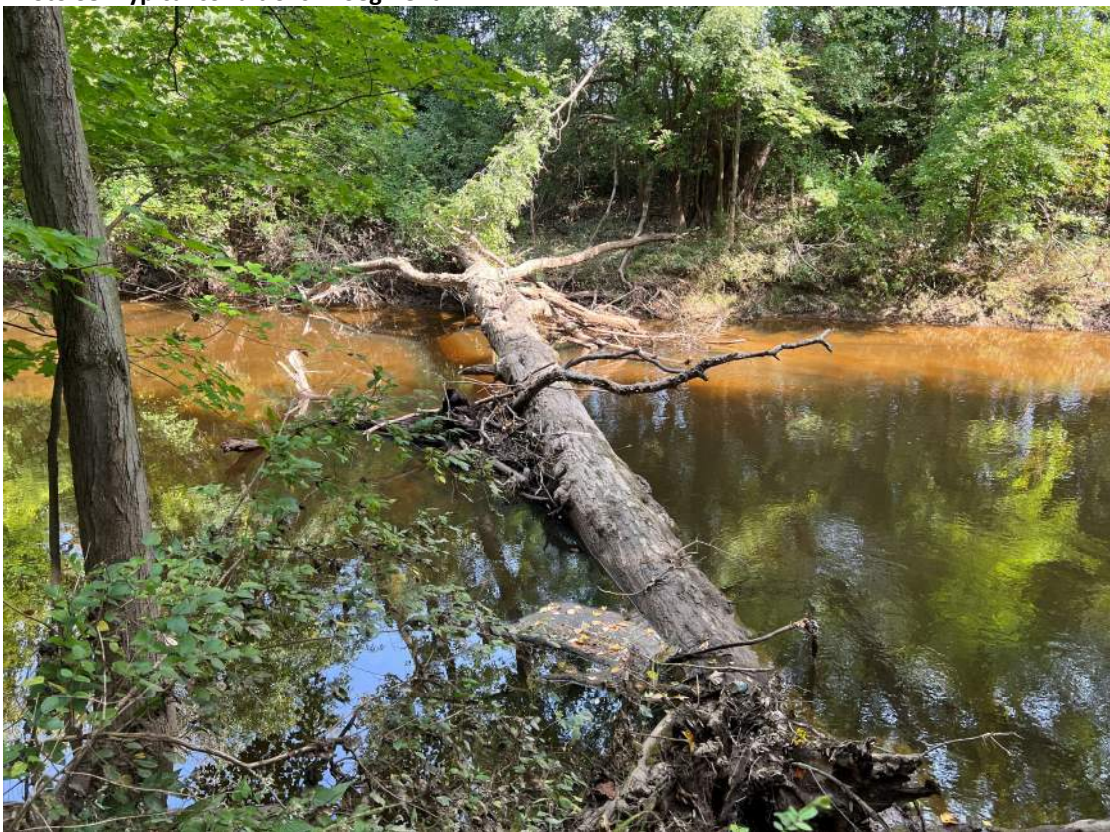
Photo 39: Tree dam in Segment 4 (see Figure 3-4, TD-21).

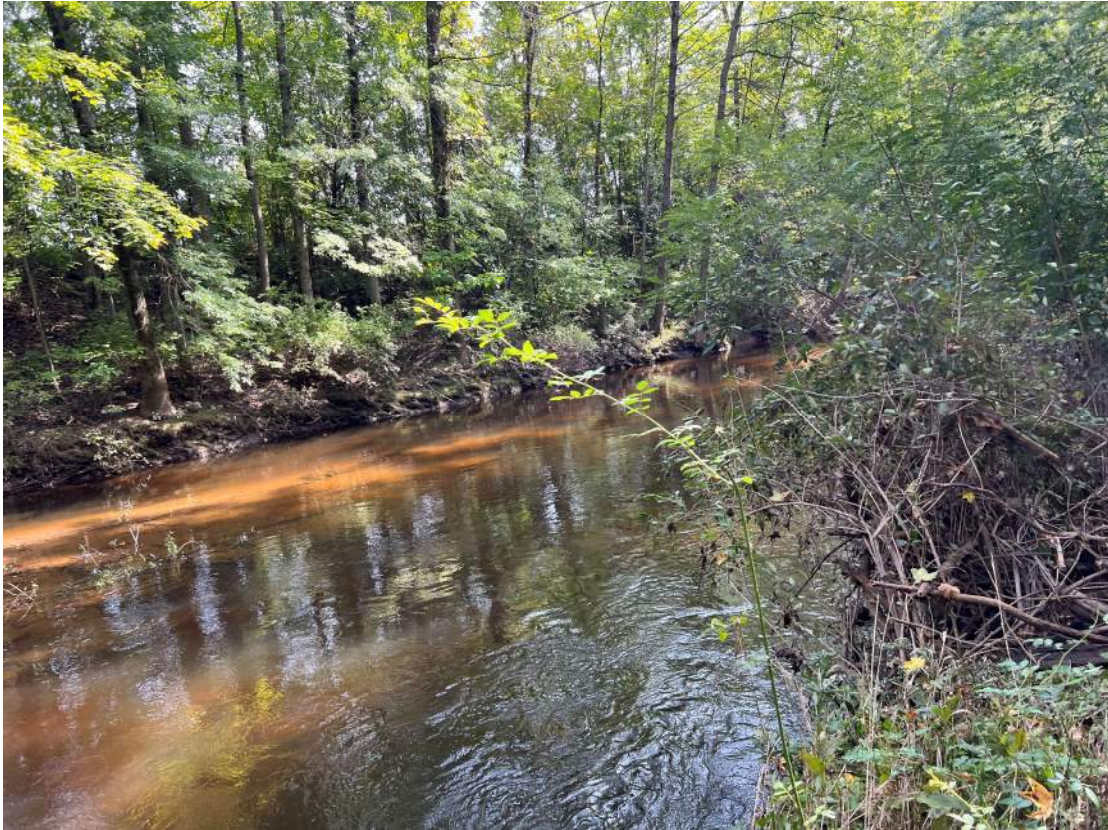
Photo 40: Typical conditions in Segment 4.

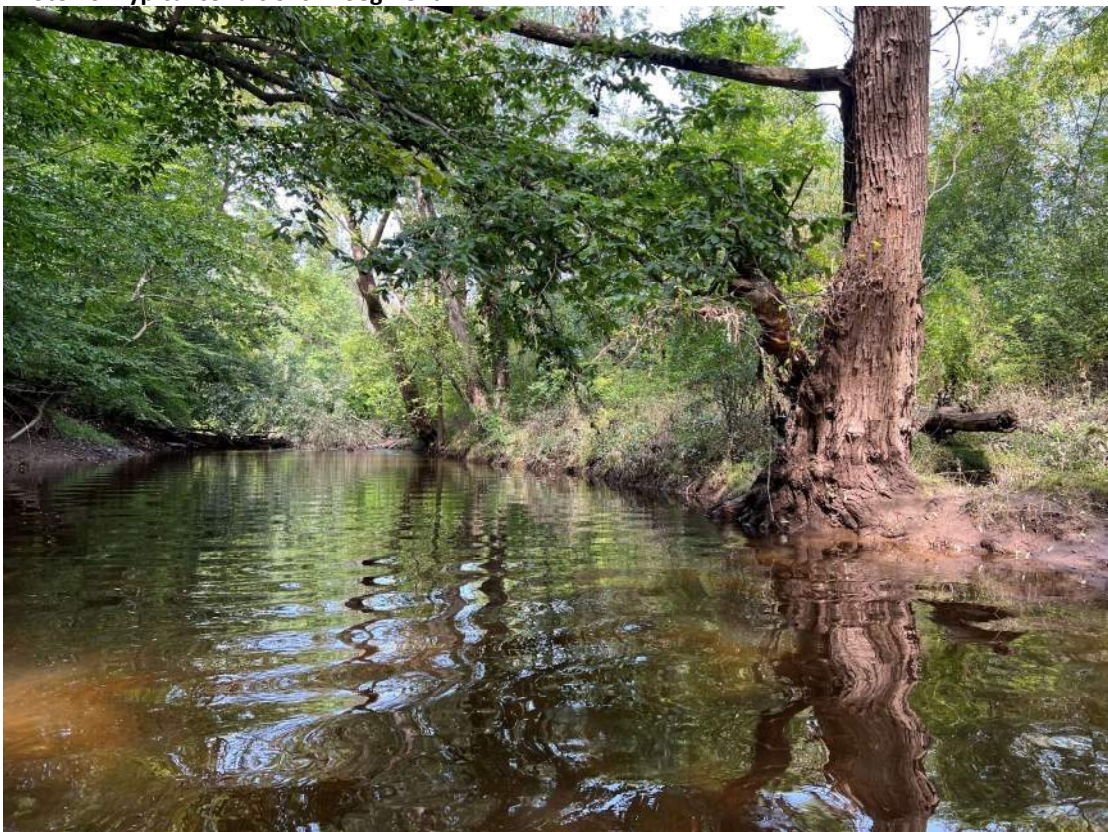
Photo 41: Typical conditions in Segment 4.

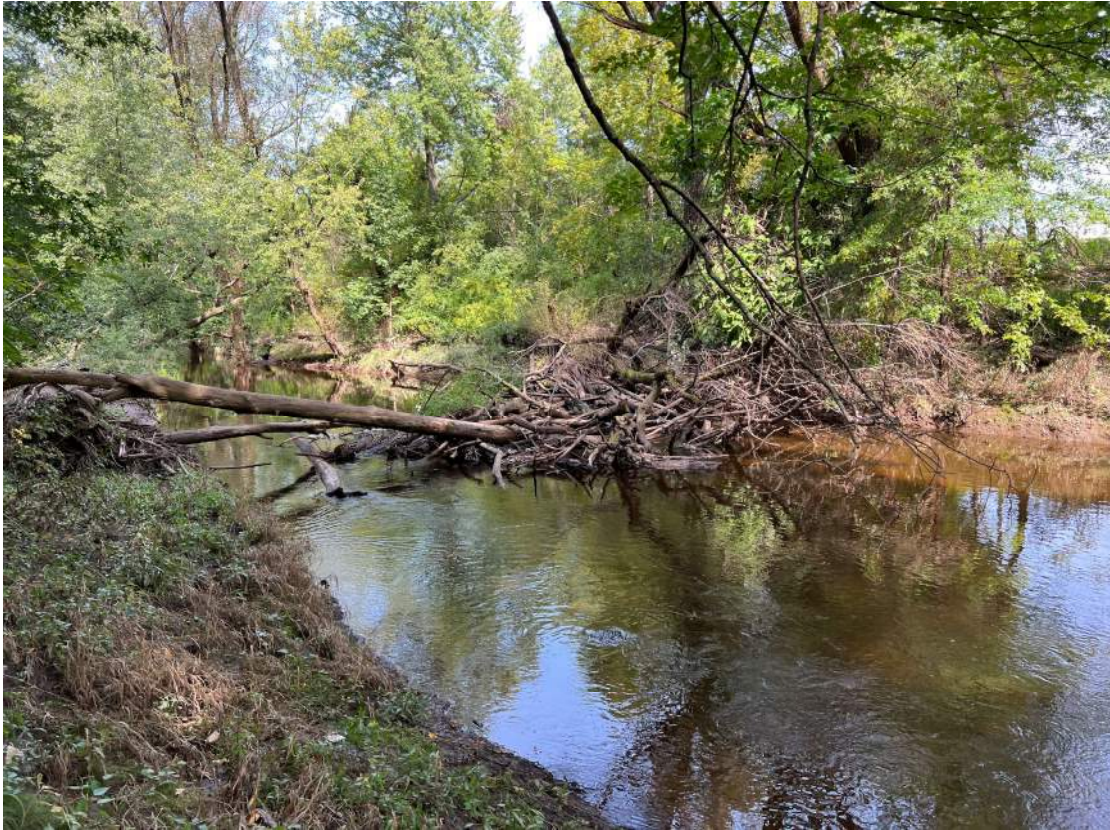
Photo 42: Downed trees in Segment 4, trees creating debris dam (see Figure 3-4, TD-22).

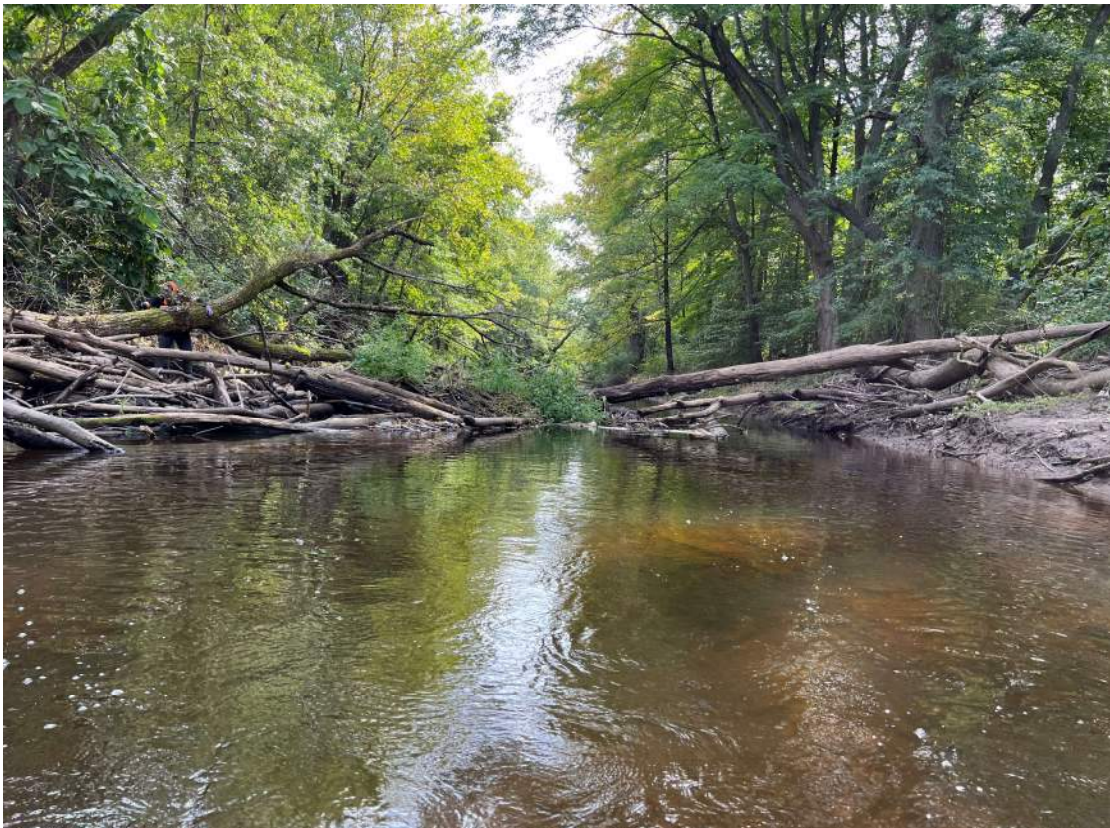
Photo 43: Downed trees in Segment 4, trees creating debris dam (see Figure 3-4, TD-23).

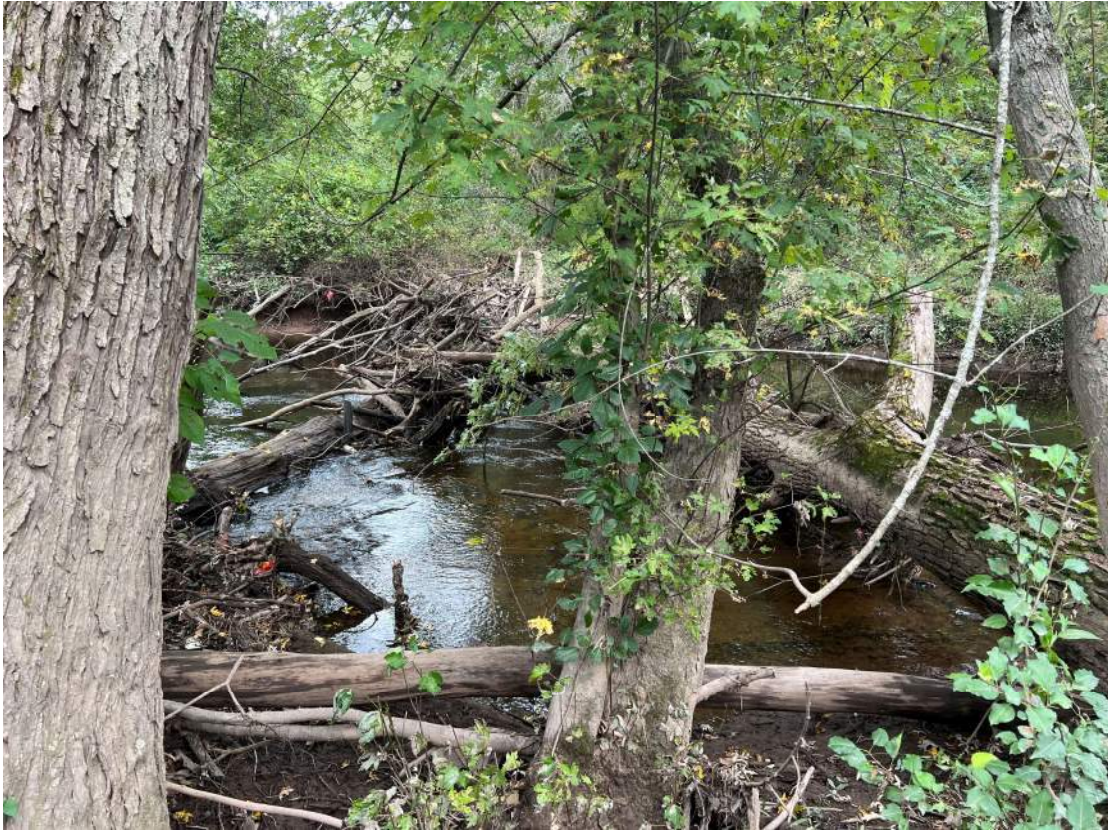
Photo 44: Downed trees within Segment 4 (see Figure 3-4, TD-24).

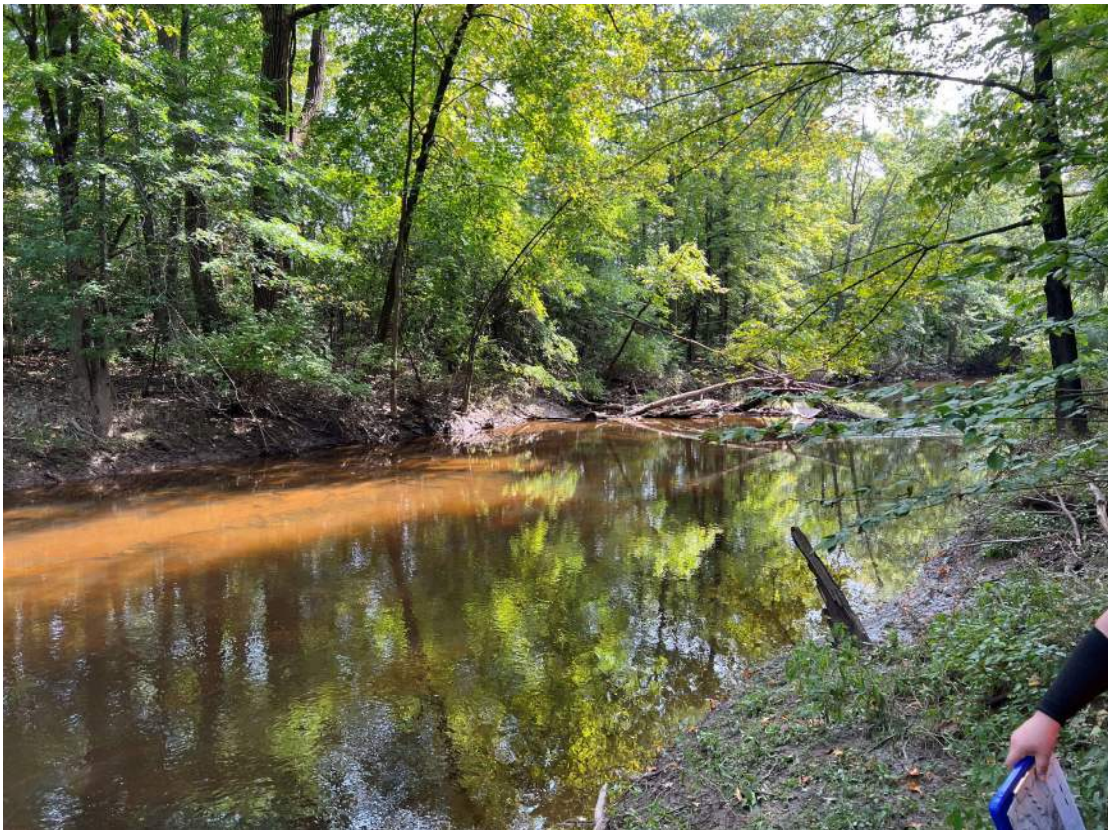
Photo 45: Bank failure and downed trees in Segment 4 (additional view of TD-22).

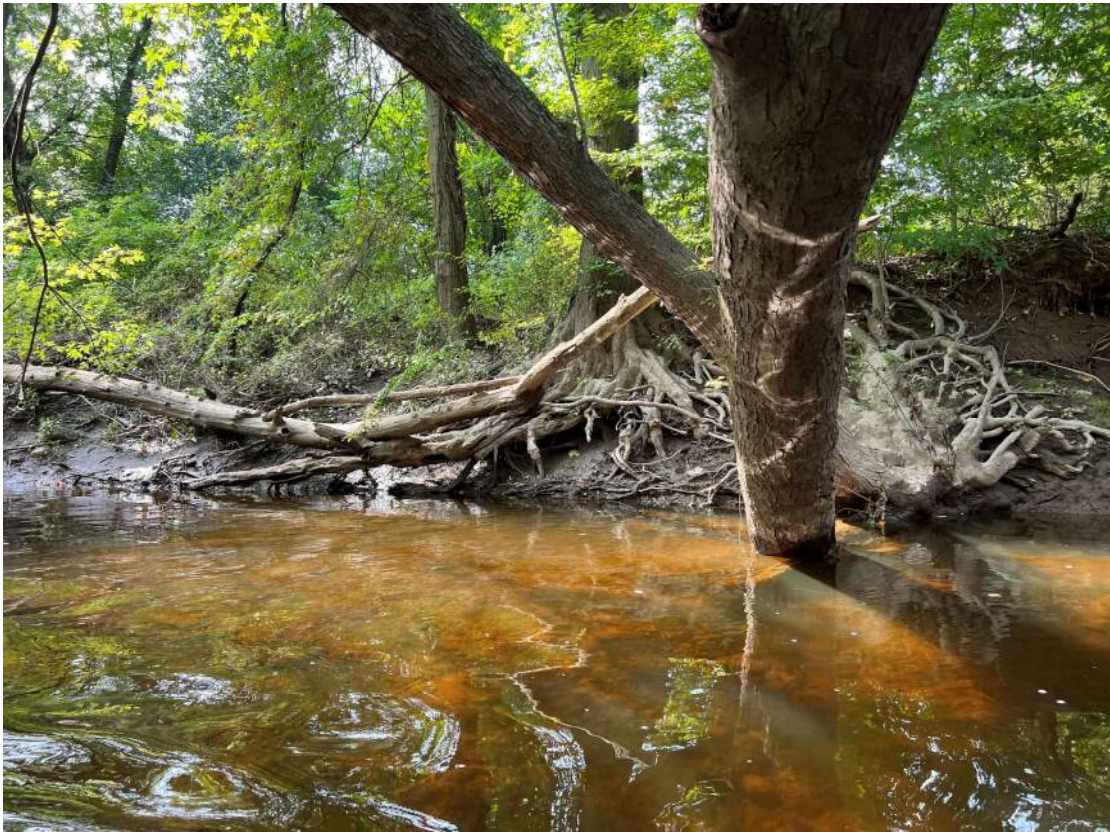
Photo 46: Undercut banks/trees, nearly vertical banks, bank failure, fallen trees in Segment 4 (additional view of trees in area of TD-23).
