Figure 1. North Branch Park River Study Area Overview
MDC Blue Hills/Granby Drainage Study
North Branch Park River Field Study
Hartford, CT

Attachment A

Site Photographs

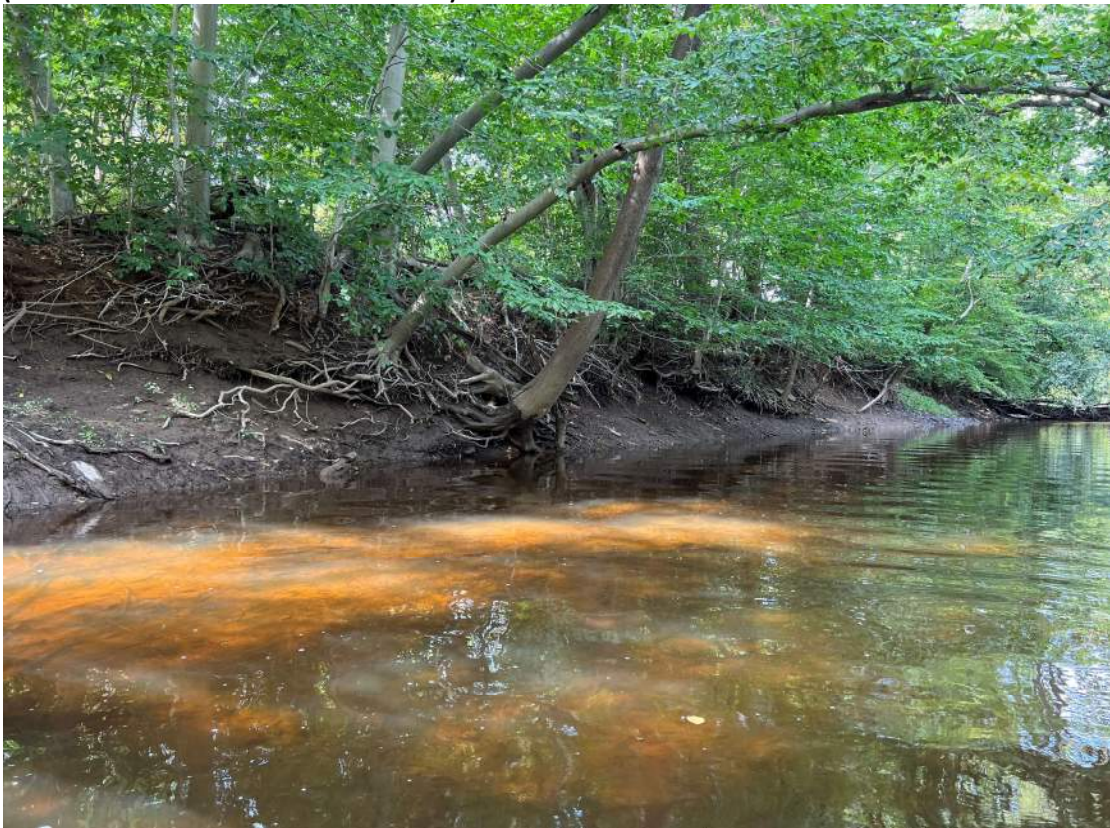
Photo 47: Eroded, steeply sloped banks, undercut trees/roots, bank failure in Segment 4.

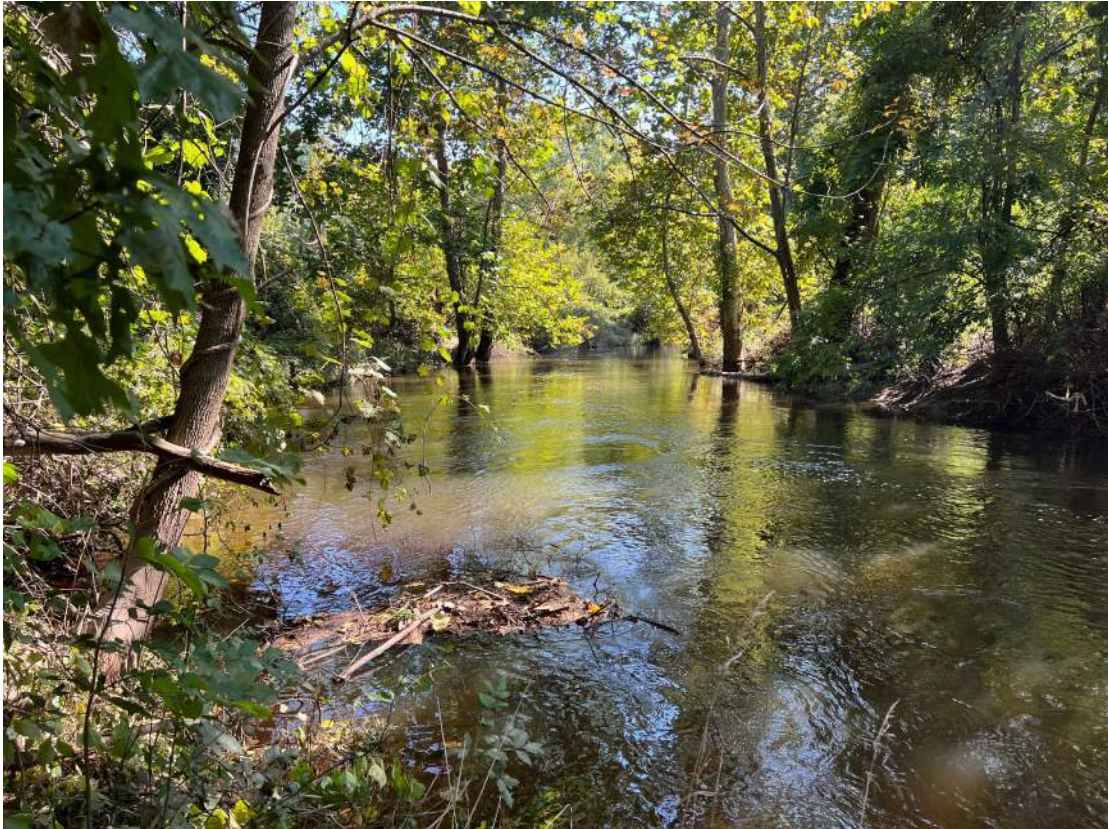
Photo 48: Typical conditions in Segment 5.

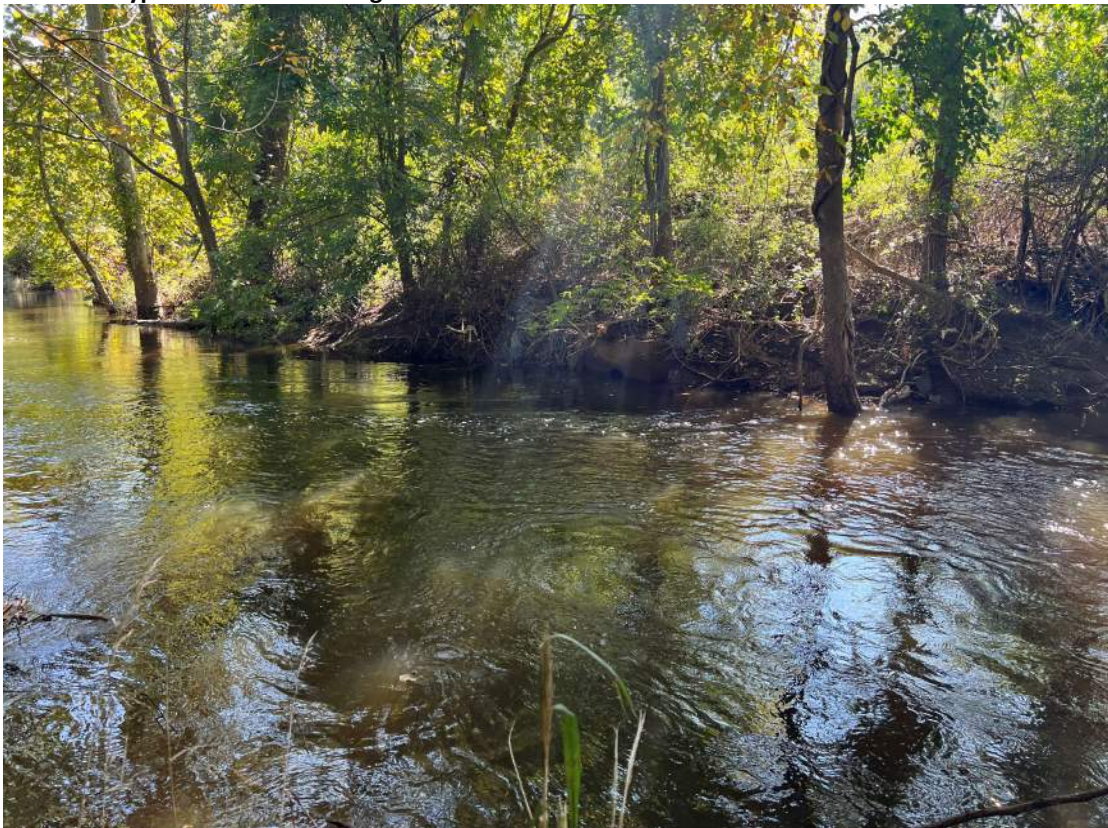
Photo 49: Typical conditions in Segment 5.

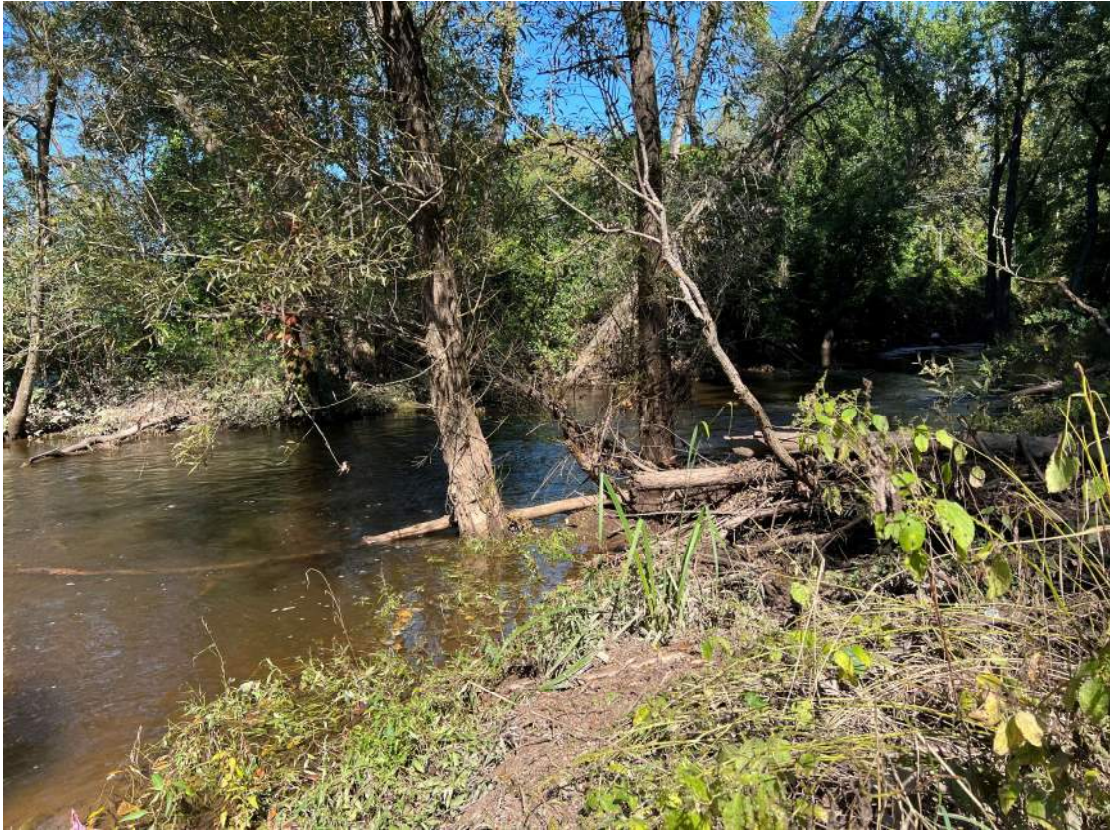
Photo 50: Overtopped banks within Segment 5.

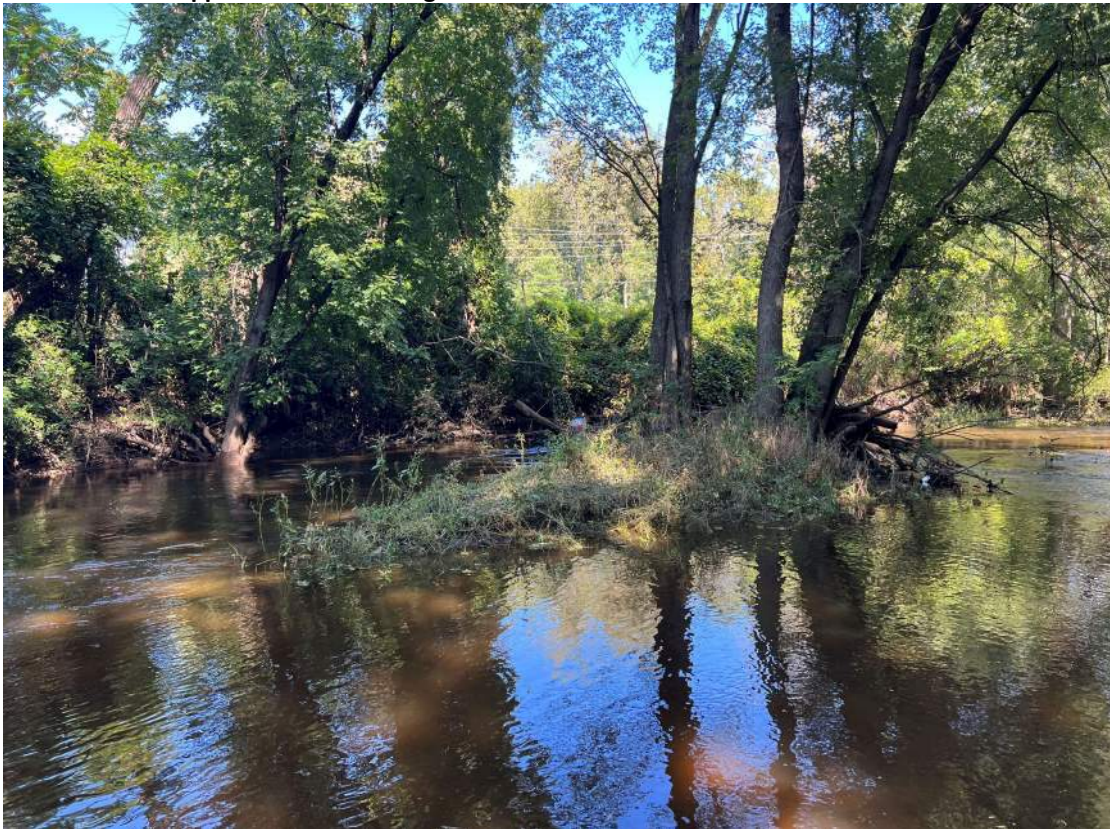
Photo 51: Overtopped banks within Segment 5.

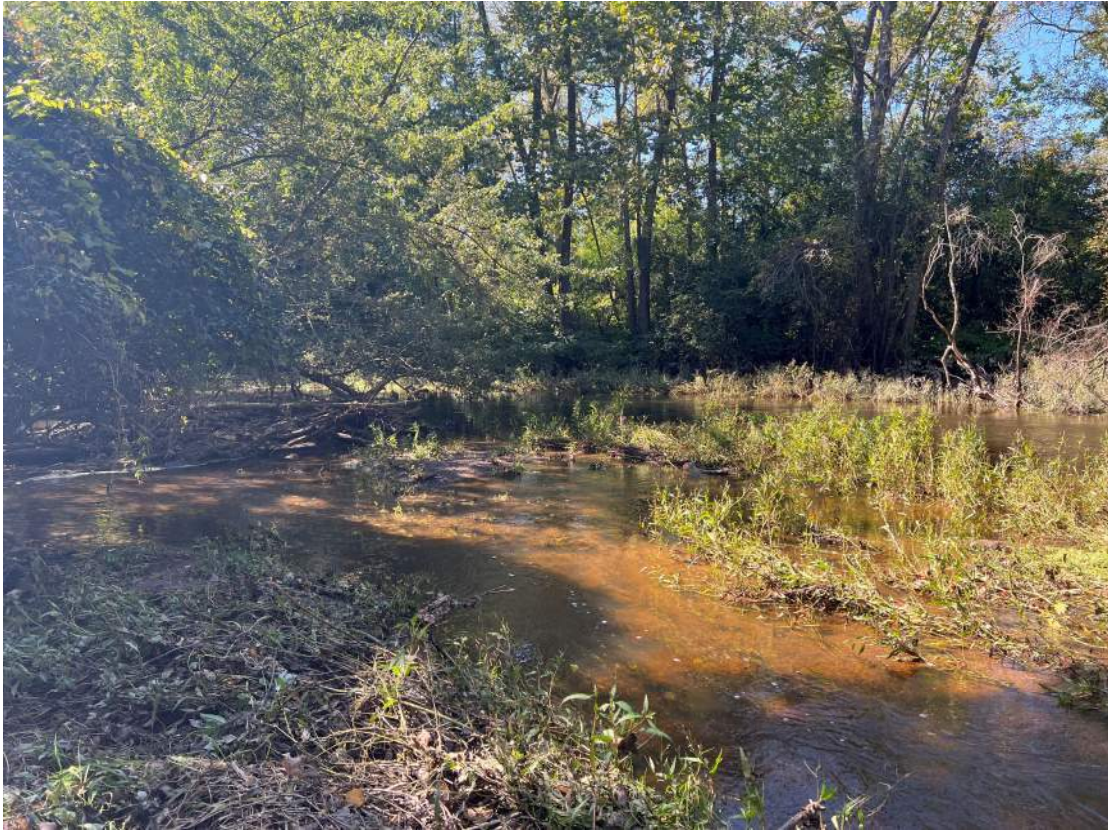
Photo 52: Overtopped banks within Segment 5.

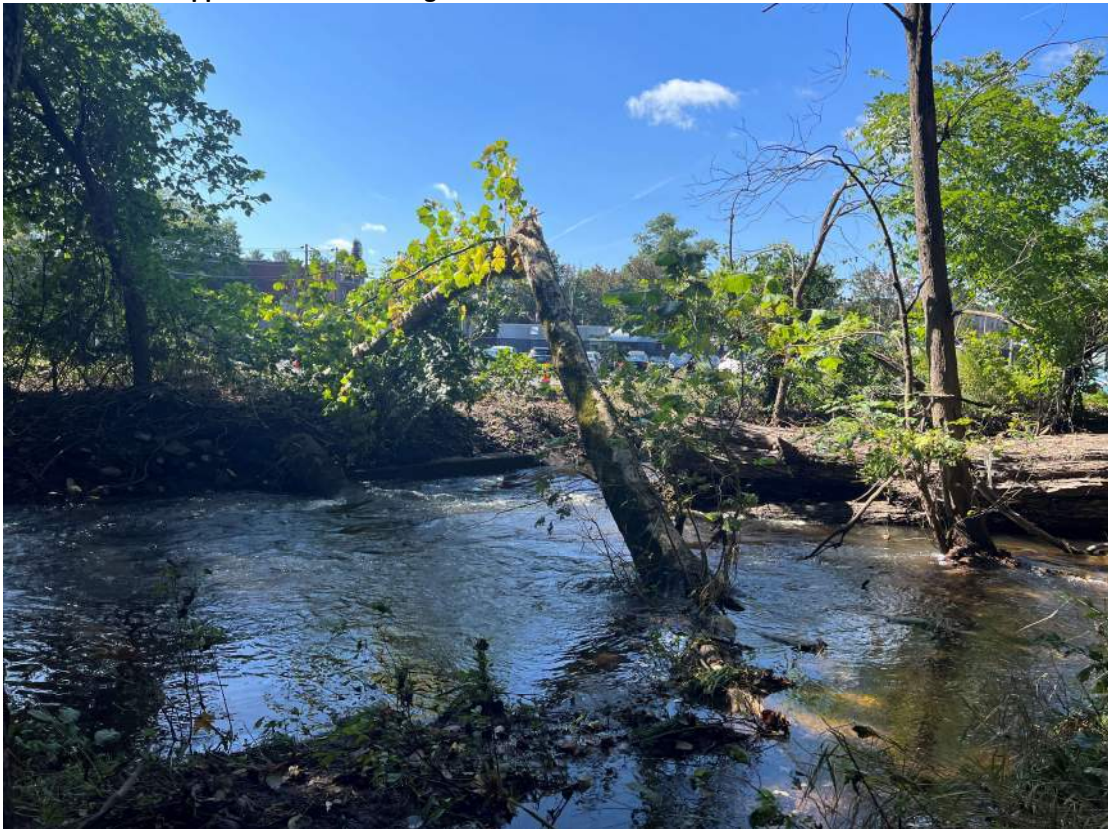
Photo 53: Clearing along riverbank adjacent to parking lot.
