Hartford MDC

Blue Hills/Granby Area Drainage Study
July 18, 2024

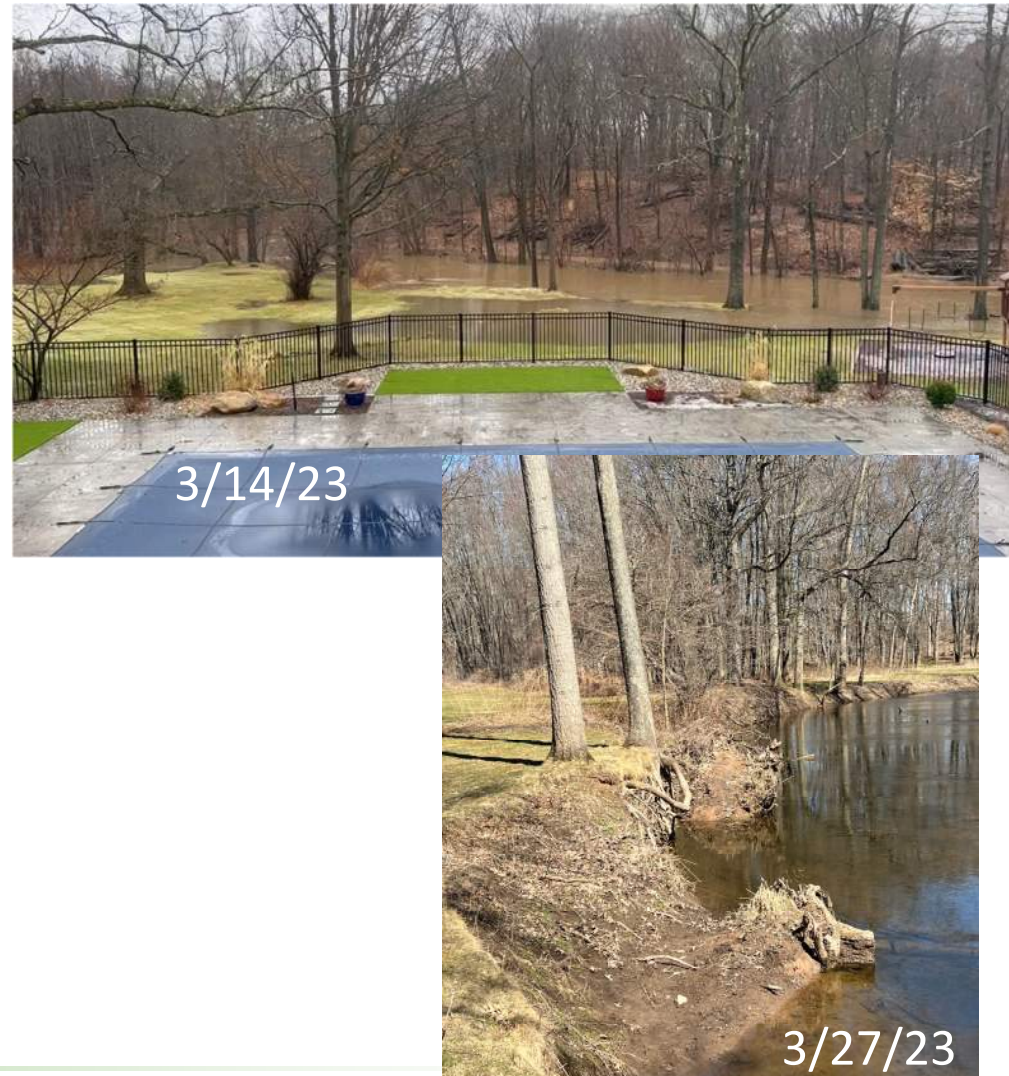
Flooding Example: 150 Scarborough St - Backyard

- NPBR flooding into yard
- Riverbank erosion
 - Property owner claims a 5-10' loss of property
- NBPR section owned by private properties
- If NBPR improved and regularly maintained, up to 2-foot reduction of flooding height
 - Less frequent
 - Smaller impact area

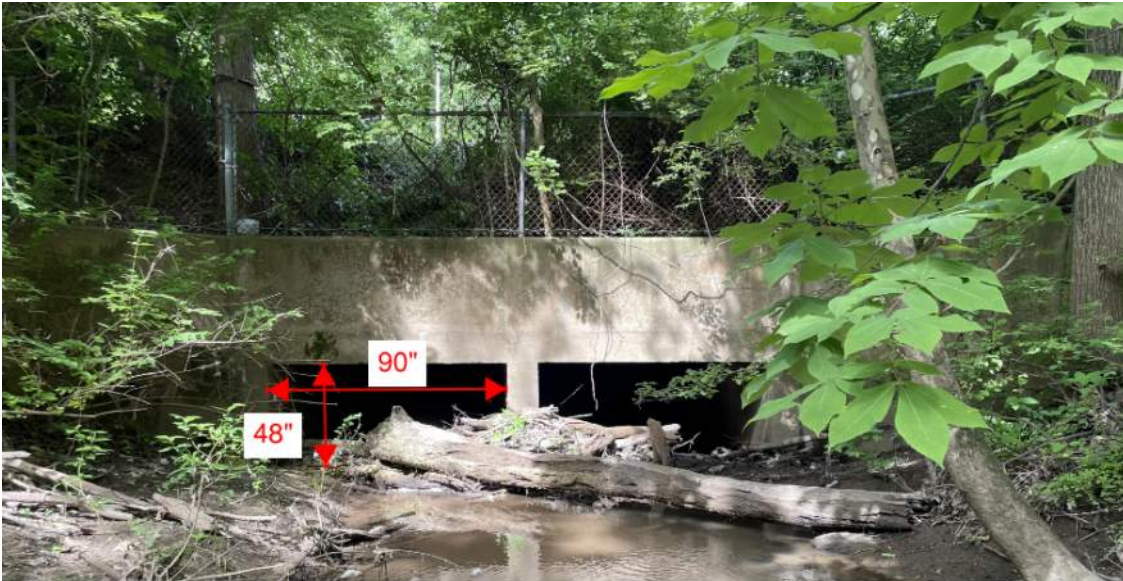
Mark Twain Drive Culvert – Maintenance

Looking downstream, toward Mark Twain Drive
Field Visit June 3, 2024

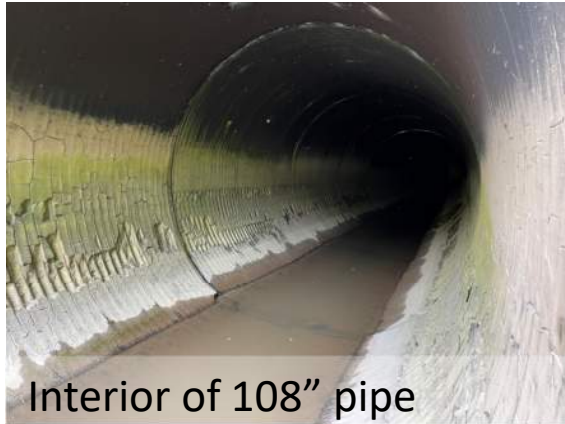
Interior of 108" pipe

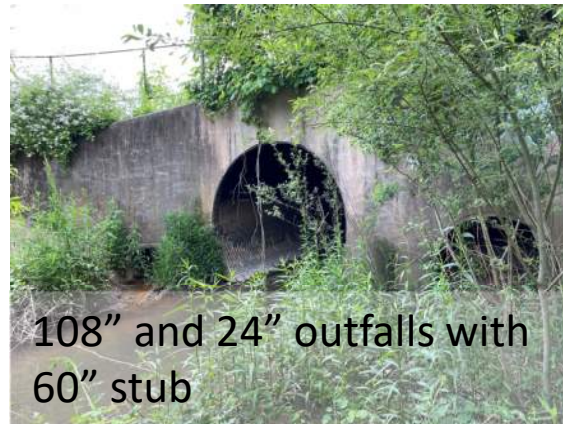
108" and 24" outfalls with
60" stub

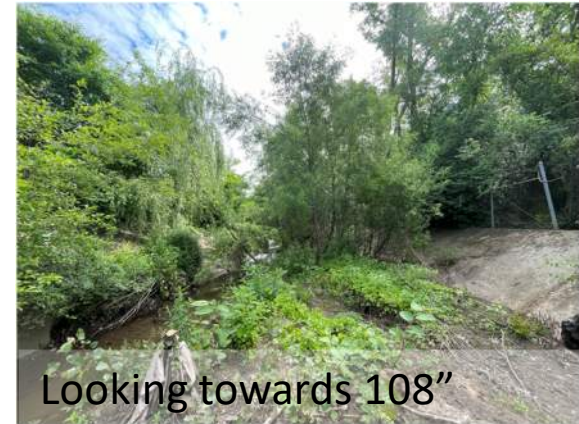
Looking towards 108"

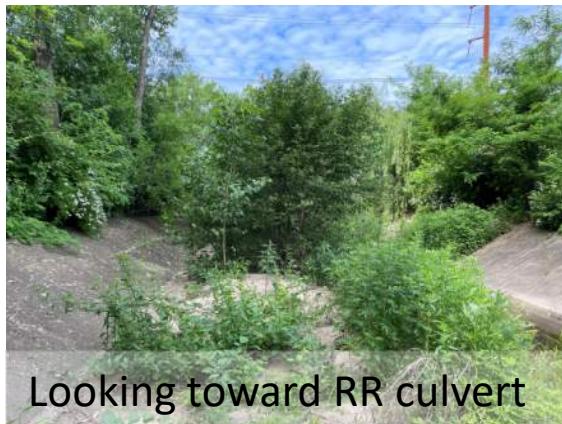
Looking toward RR culvert

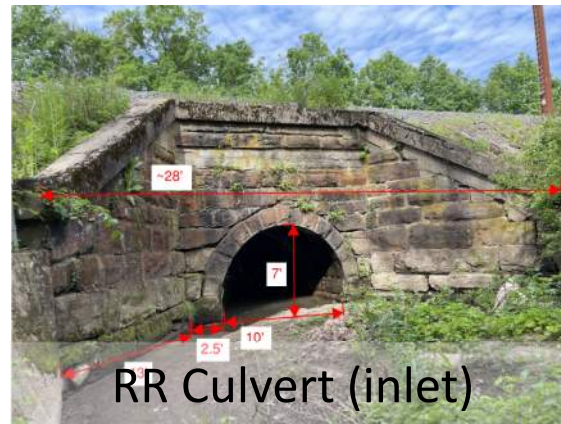
RR Culvert (inlet)

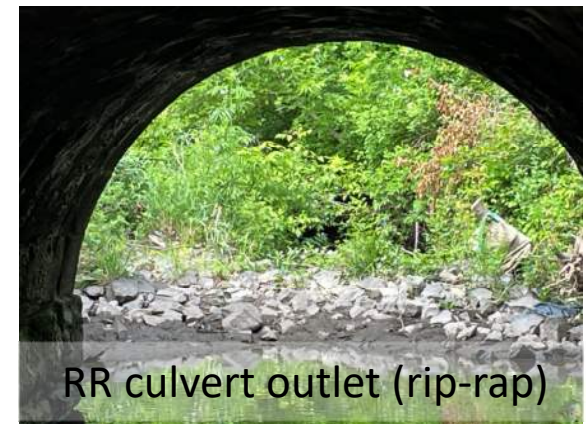
RR culvert outlet (rip-rap)

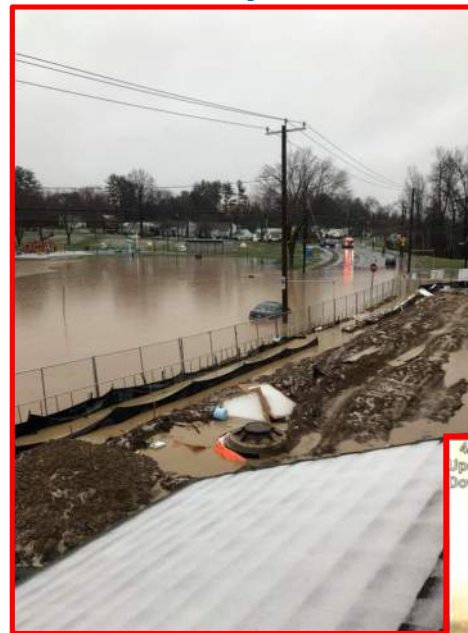
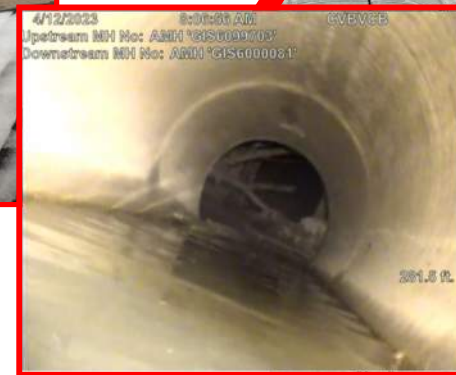
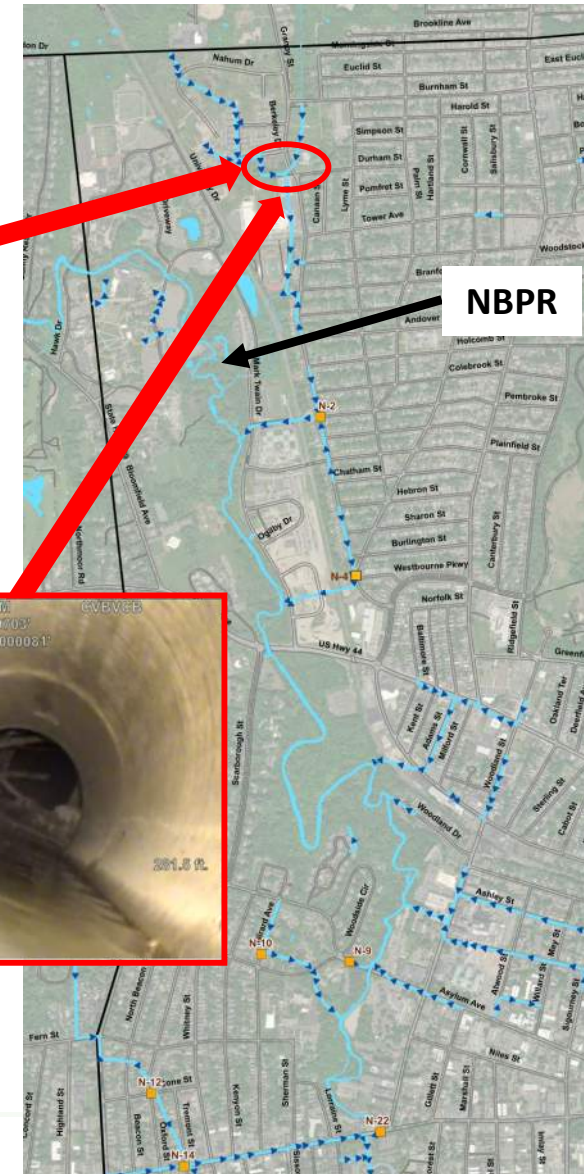
Granby Street Conduit – upstream end

- Located in Granby Street near Nahum Drive/ Boys and Girls Club (area that frequently floods)
- City removed large trees from 96" pipe
- Sediment was not removed

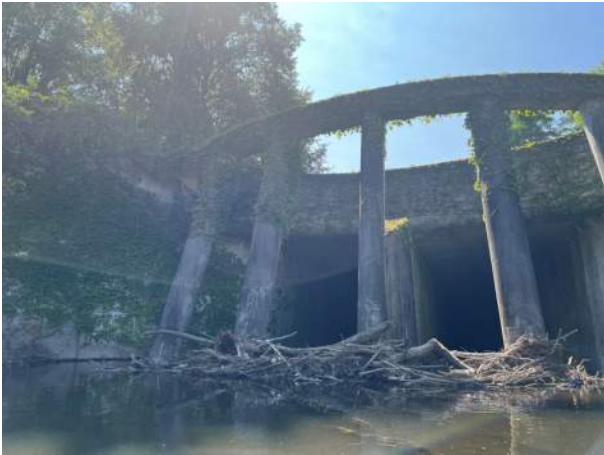
- Entrance blocked by debris
- Sedimentation and submerged vegetation
- Most significant sediment depth found here

Debris dam at start August 23, 2023

- Remove trees/debris dams regularly (especially at PRC entrance)
- Remove leaning trees on banks
- Clean existing pipes, culverts, channels

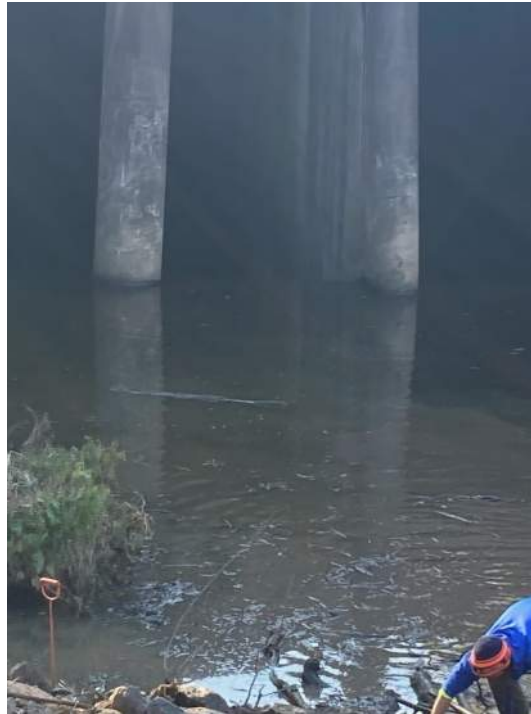
PRC during cleaning, Nov 6, 2023

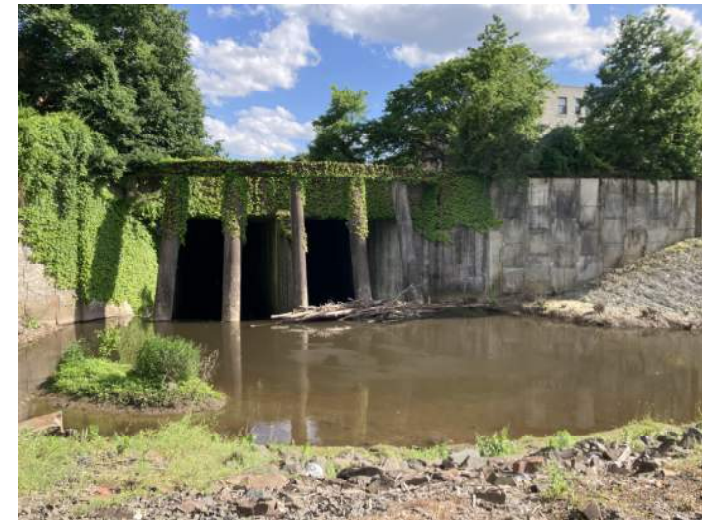
Debris dam after cleaning, May 28, 2024

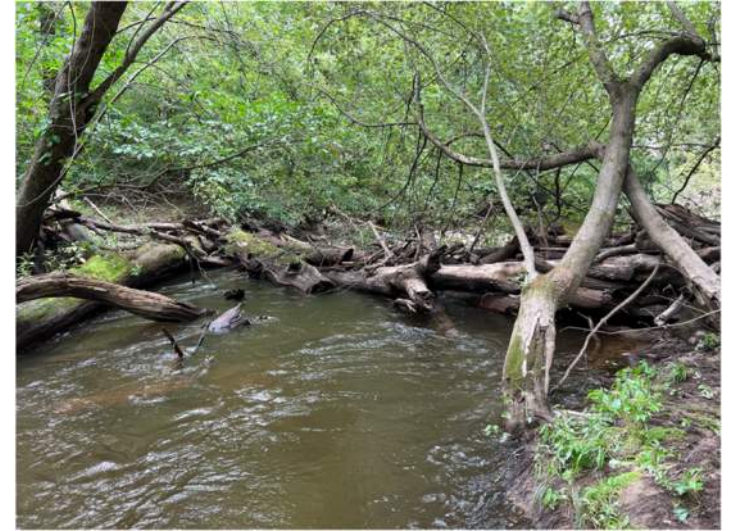
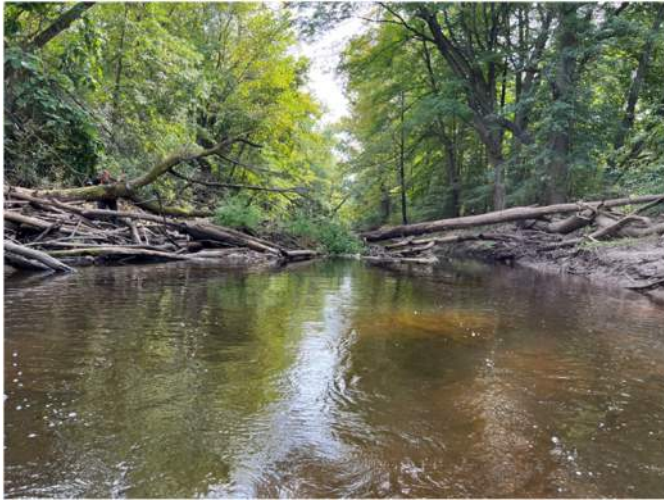
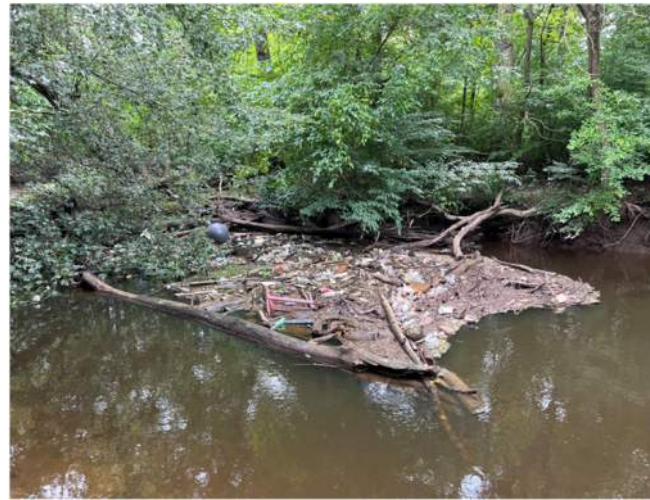
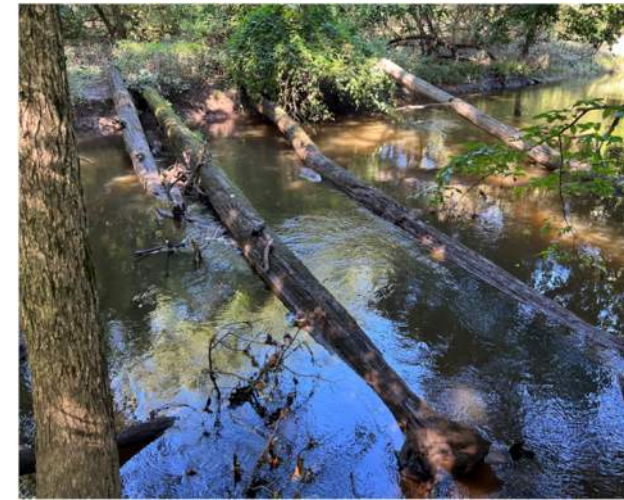
- Tree Dams:
 - Lots of tree dams and downed trees, collecting trash (see handout, Figure 2)
 - North of Albany Ave had the most tree dams within the project area, and most tree canopy

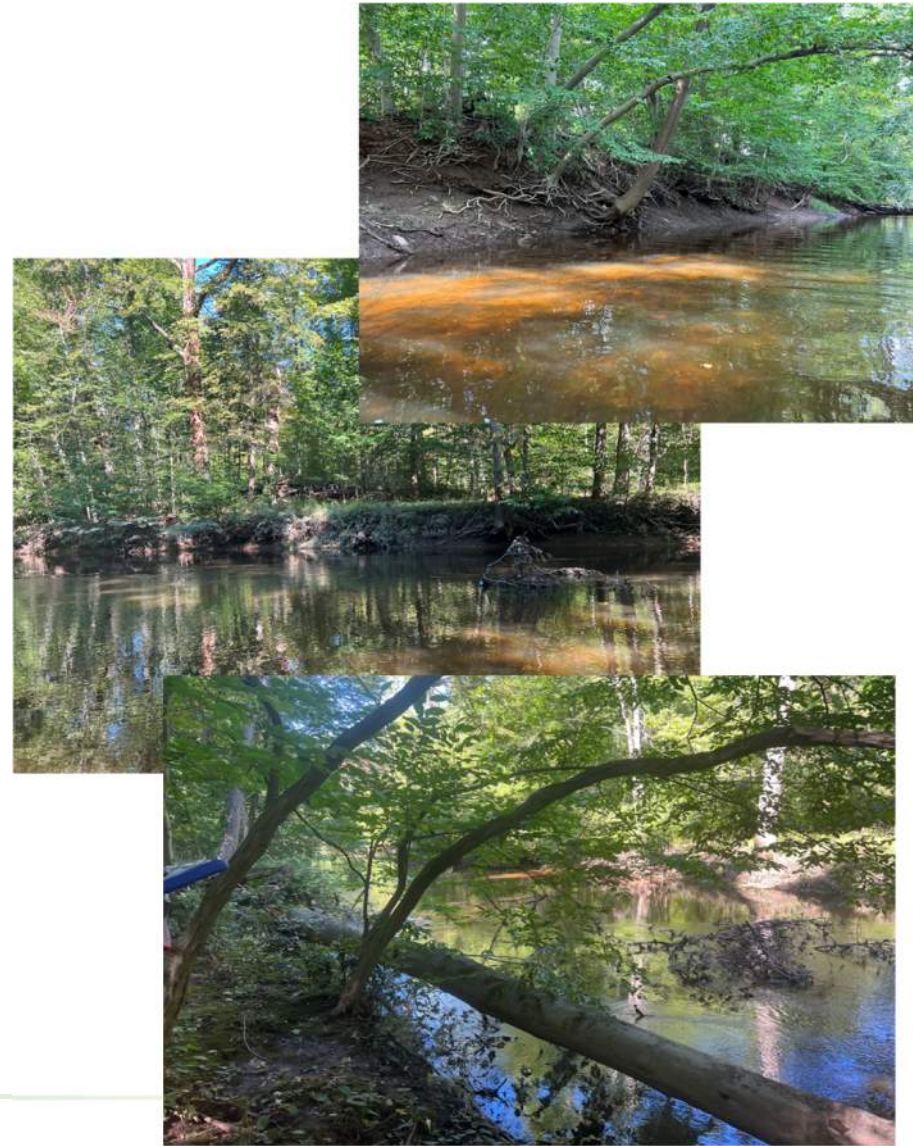
- Undercut banks: undermines trees on the banks causing them to eventually fall in and mobilize downstream
- Near vertical banks: cuts off river from flood plains and causes flows to reach downstream much quicker, **increasing the chances of flooding and erosion**

- Grade back banks to restore near-dynamic equilibrium
- Widening banks and dredging in selected locations
- Reinforce actively eroding sections with root wads or rip rap
- Increase natural floodplain storage by excavating basins
- Increase woodland floodplains by removing parking lots (Woodland St, UHART), MS4 benefit
- Construct berms around flood prone properties (ex: University High School of Science & Engineering on Mark Twain Dr)

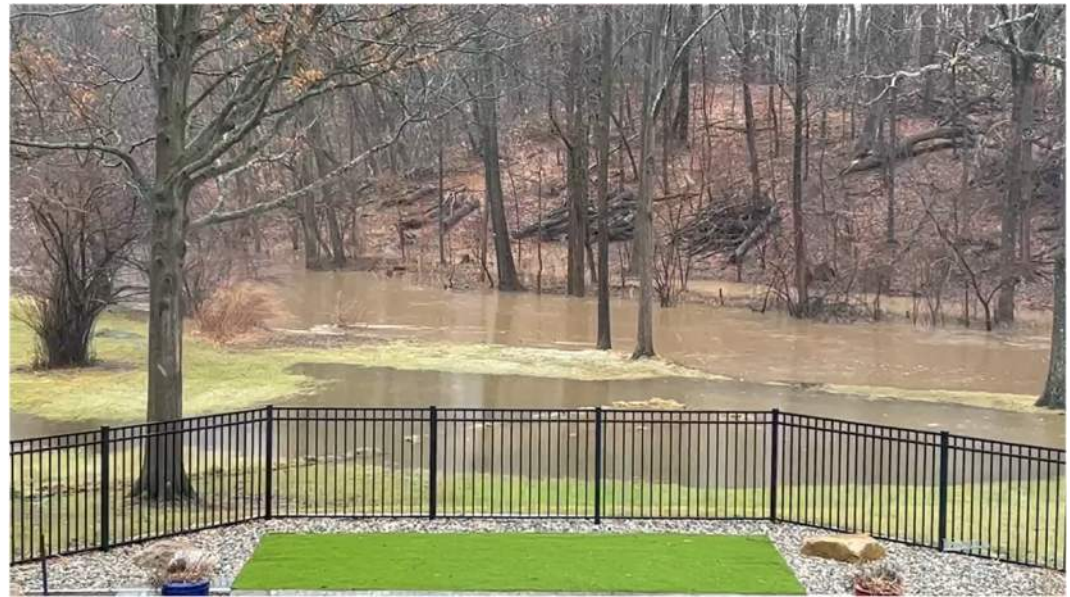
Backyard of 150 Scarborough St

- Structures in Floodplain:
Many adjacent properties have structures (pools, playsets, patios, etc.) located within floodplain, and no forested buffer; grass right up to banks

- Educate property owners on floodplains and forested buffers (Scarborough St)
- Do not allow further development in floodplain
- Relocate housing out of floodplain via land purchases (Woodland Dr), MS4 benefit
