Hartford MDC

Blue Hills/Granby Area Drainage Study
July 18, 2024

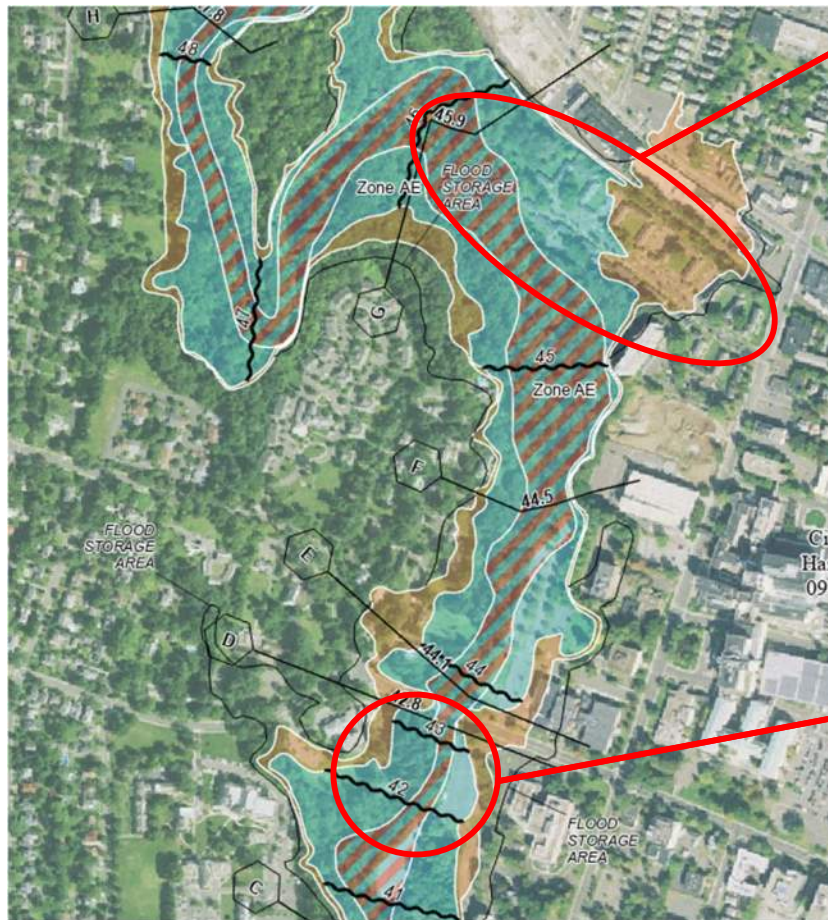
Woodland St Parking Lot, Woodland Dr Apartments

Woodland Dr Apartments

Woodland St Parking

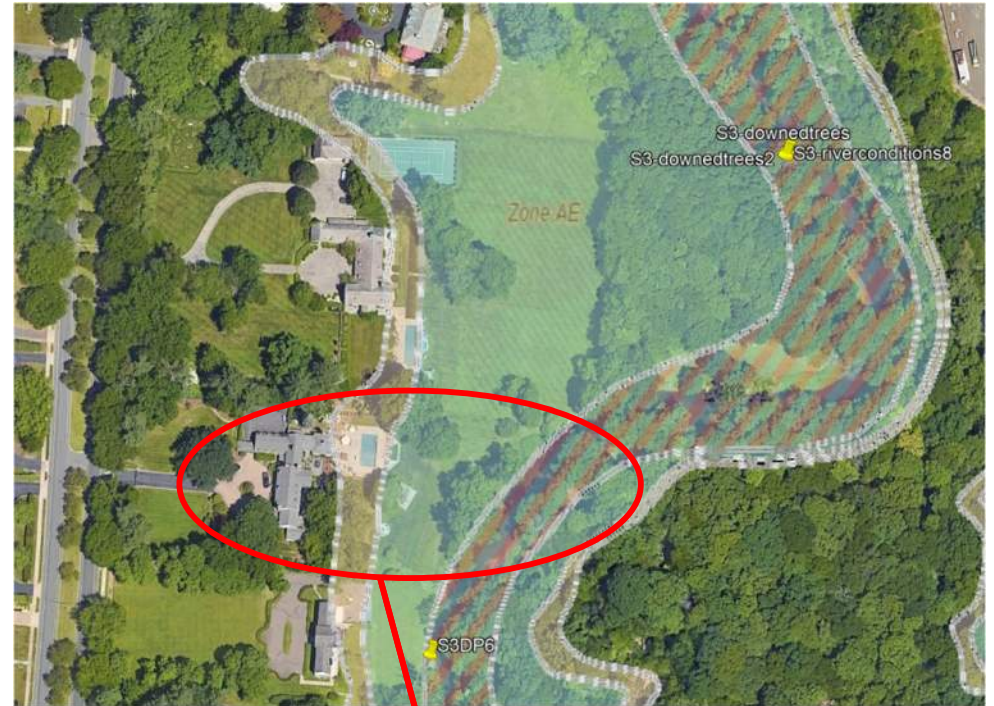
Flooding Example: 150 Scarborough St - Backyard

- NPBR flooding into yard
- Riverbank erosion
 - Property owner claims a 5-10' loss of property
- NBPR section owned by private properties
- If NBPR improved and regularly maintained, up to 2-foot reduction of flooding height
 - Less frequent
 - Smaller impact area

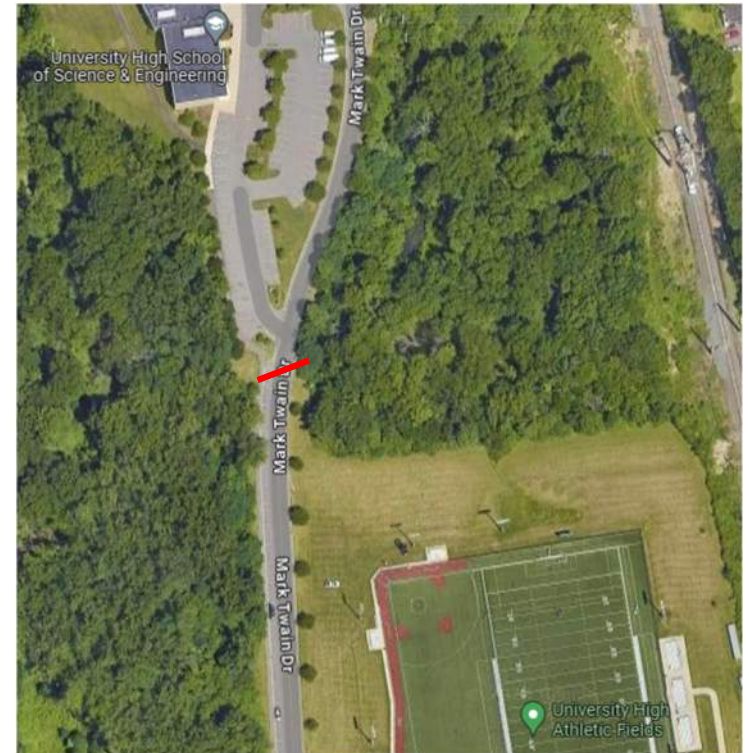
University of Hartford (UHART) Flooding

- Lower-lying parking lots flood
- UHART policy that owners are parking at their own risk

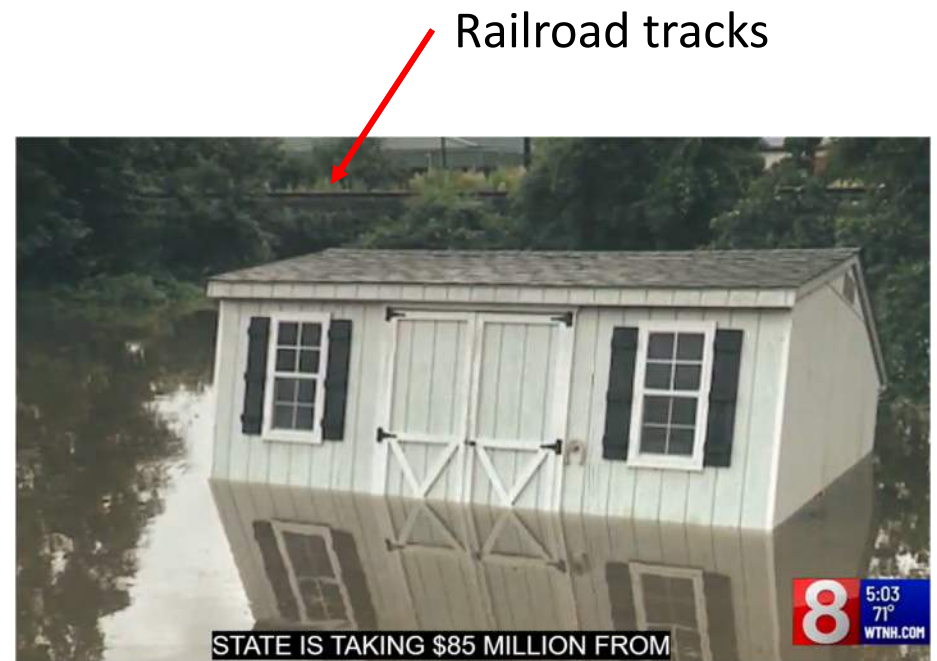
Flooding between Railroad Tracks and Granby St

Flooding Between Granby St and Railroad

- Railroad tracks built before homes on Granby St
- Depressed area between the tracks and the houses does not have proper drainage
- Residents experience flooding on their private property
- In TV report, residents state that is not a new problem, but something that has been prevalent for decades

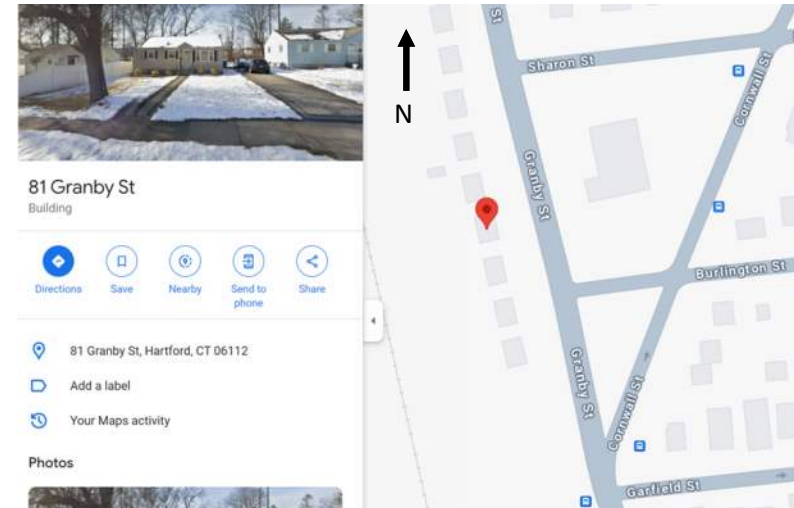
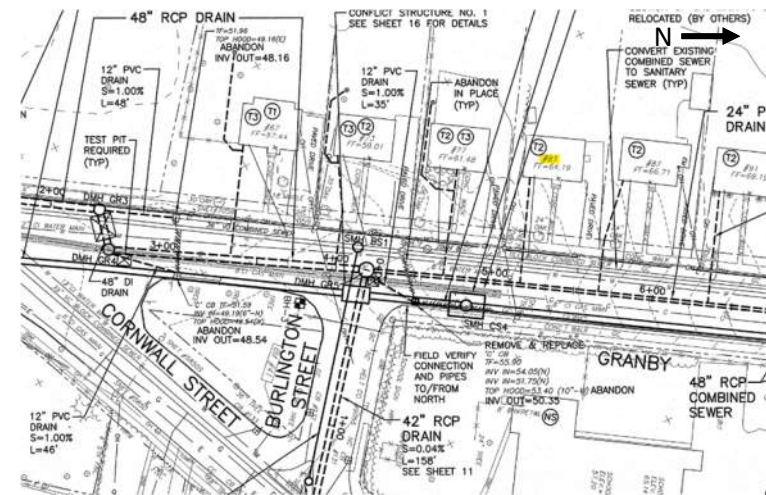
81 Granby St

- Located near the intersection of Granby St /Cornwall St / Burlington St
- Separated area with drains connected to N-4 outfall (MDC Granby 5 project)
- Railroad tracks berm in the backyard contributing to flooding (tracks higher than Granby St)
- City hired Freeman Engineers to design storm drainage system to relieve backyard flooding and connect to Westbrook Village
- DOT requested drainage study to determine capacity and license agreement for maintenance
- City needs to coordinate with MDC on where to discharge drainage
- Similar localized flooding as previous backyard flooding example

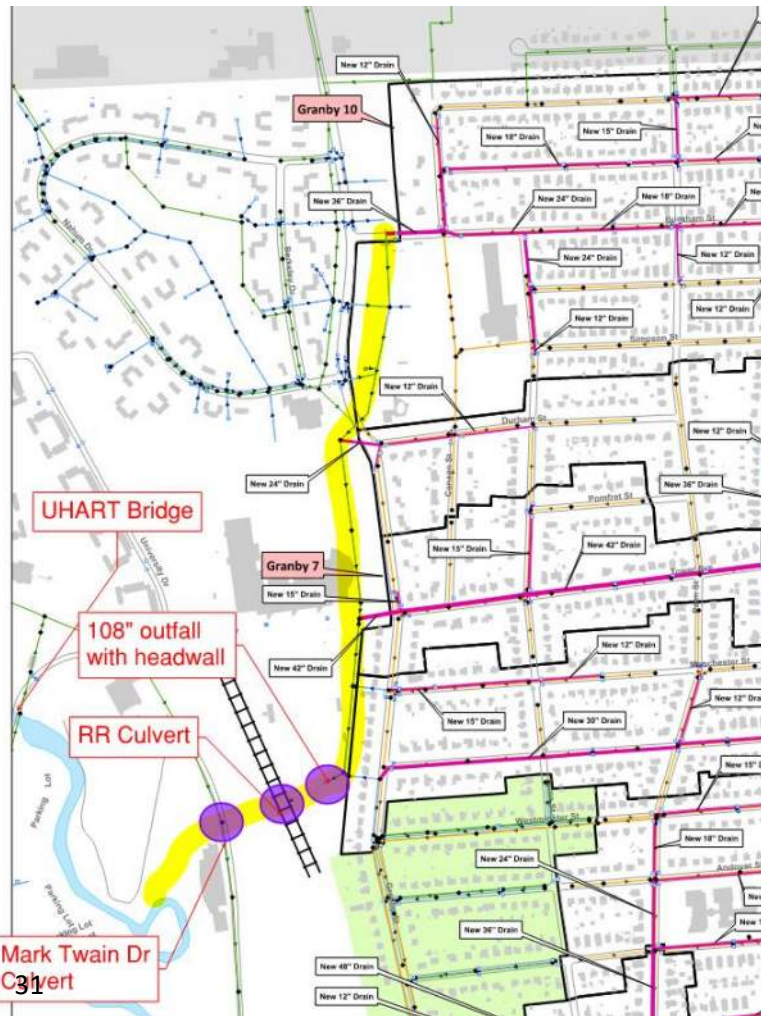
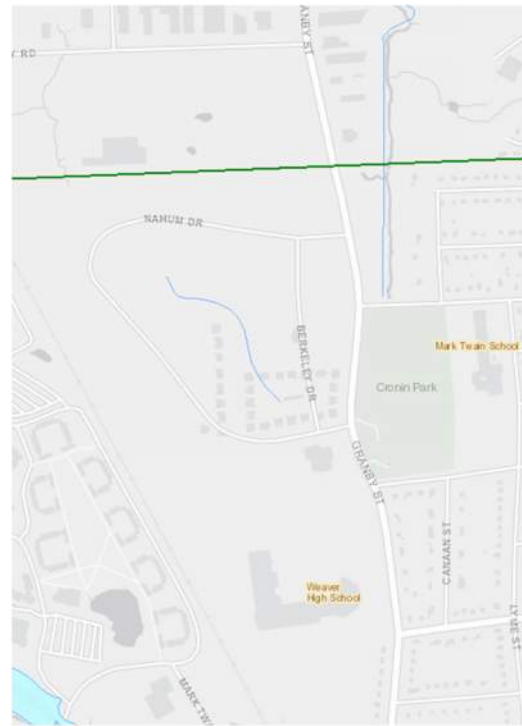
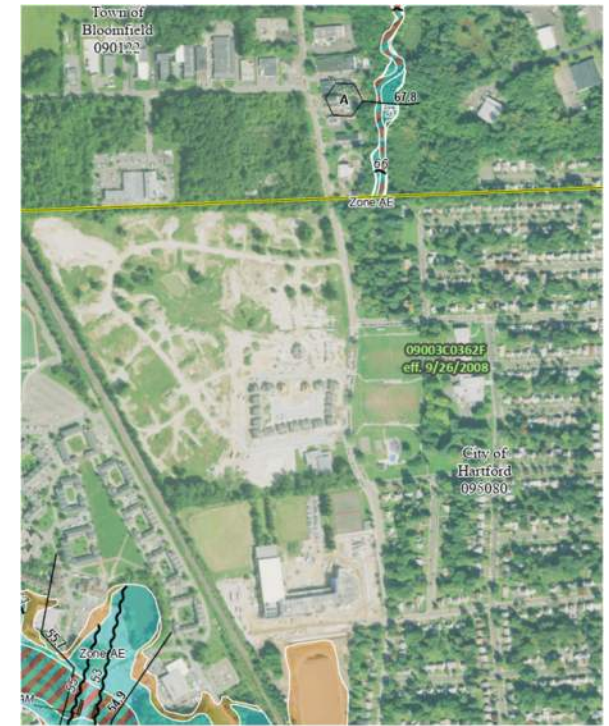
Unnamed Stream / City-owned 108" Granby St Conduit

Two unnamed streams were culverted in the Granby St Conduit from south of the Bloomfield Town line to an outlet south of Weaver HS fields, pipe diameter from 90" to 108"

- Needs maintenance to address current flooding issues
- New drains could connect to this conduit if the pipe was better maintained and not already causing flooding
- Currently proceeding with **new drain outfall** for this area unless City can clean and improve the existing pipe because don't want to exacerbate flooding
- Will cause delay to schedule for separation in area as outfall would need to be built first

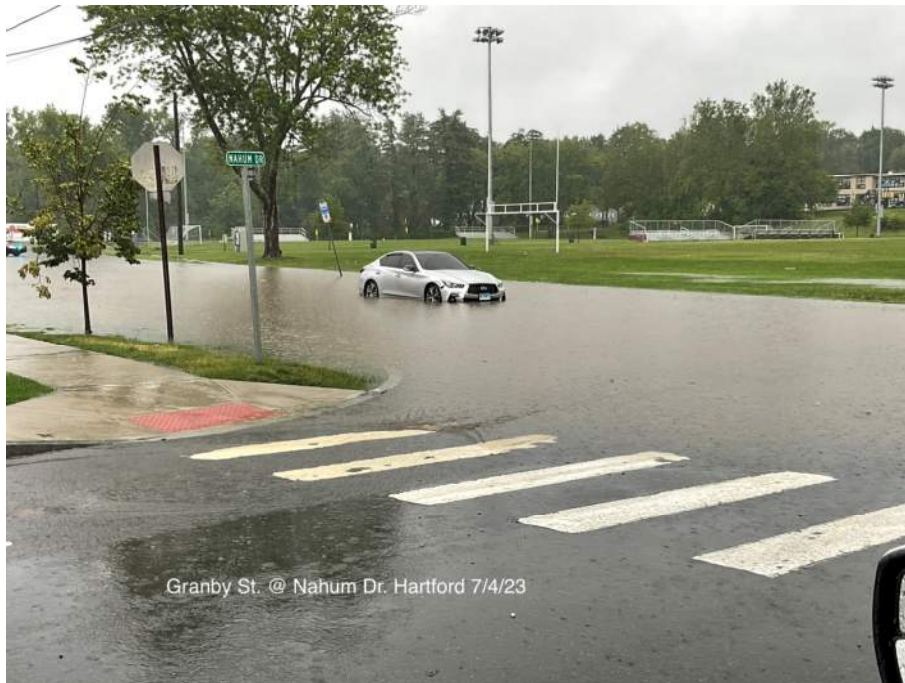
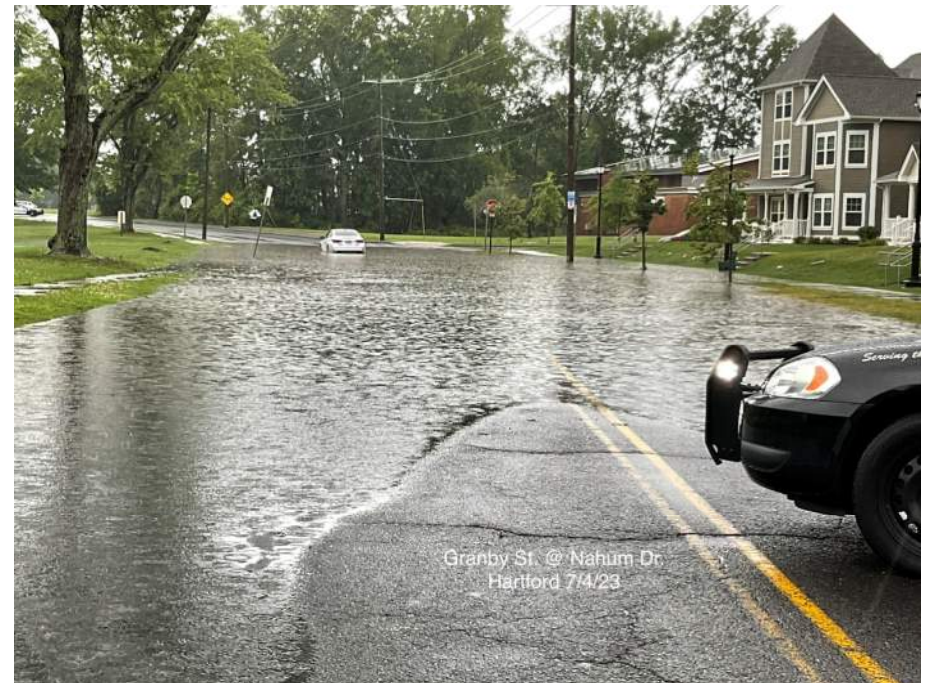
Flooding Granby St Conduit Inlet

Nahum Dr / Granby St / Burnham St Area

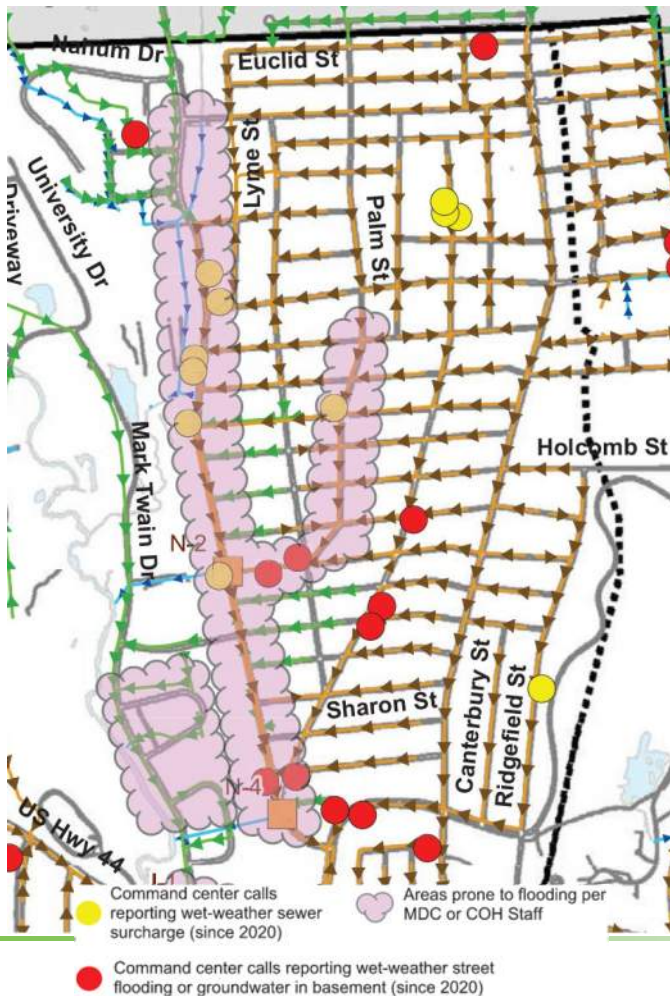
Upland Flooding Reports – MDC combined sewer

Flooding Reports on Cornwall St, Lyme St, Morningside St, Palm St

- MDC Sewer Separation will improve conditions
 - New storm drain pipes for a 10-year design storm (DOT standard)
 - New storm drain lateral to each property for sump pump connection
 - Will not provide yard drain connections
 - Will still require regular catch basin cleaning and street sweeping

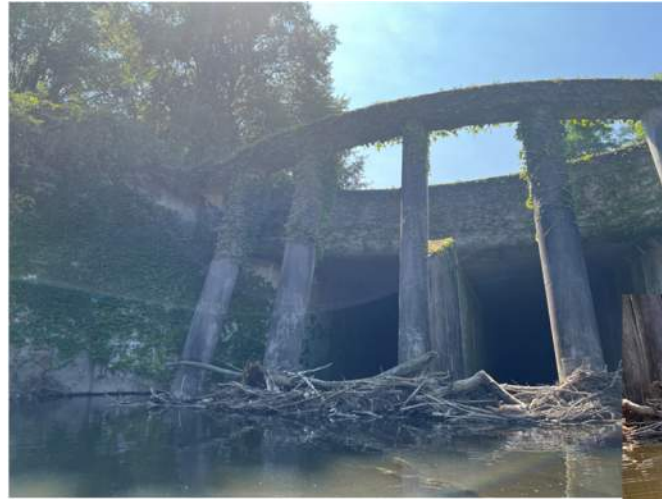
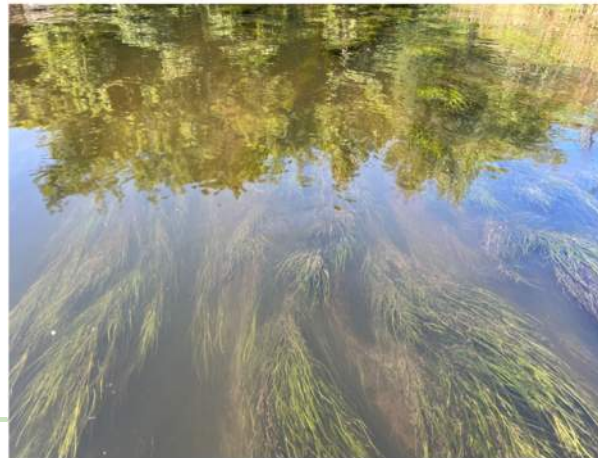
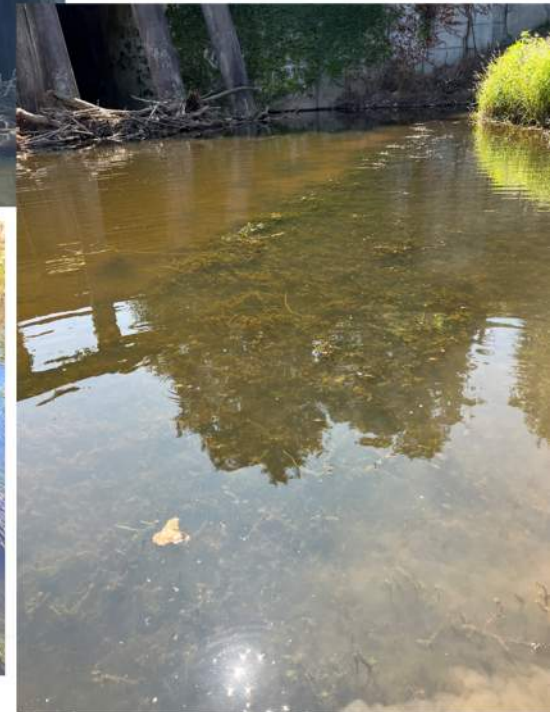
Field Investigation Findings - PRC Entrance

- Entrance blocked by debris
- Sedimentation and submerged vegetation
- Most significant sediment depth found here

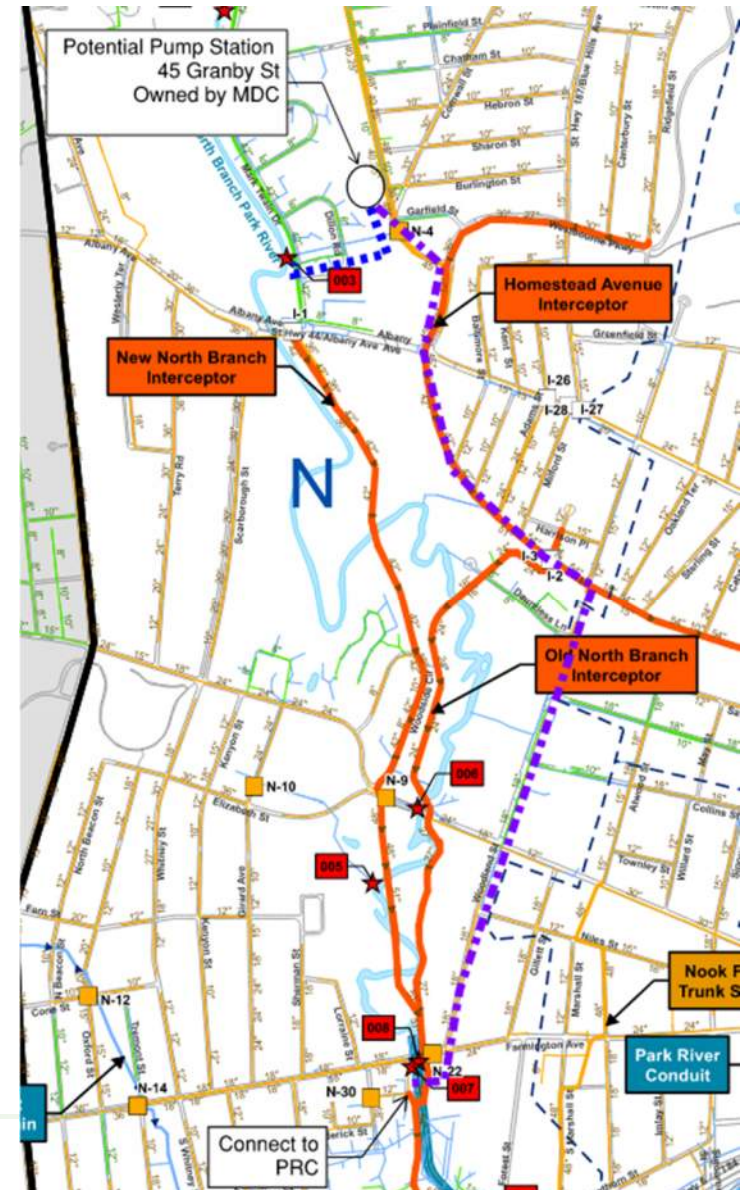
Stormwater Pumping Station

- Separation could worsen flooding along river
- If river improvements are not made, pump station (PS) may be needed
- PS Location: 45 Granby St, owned by MDC and adjacent to N-4
- Force main Option 1: 45 Granby St to NBPR through Westbrook Village
- Force main Option 2: 45 Granby St to Park River Conduit south of Farmington Ave (1.6 miles)
